Distribution and features of slope failures in Tarumizu City, Kagoshima Prefecture caused by typhoon Nabi in September 2005

TERAMOTO Yukiyo¹⁾, SHIMOKAWA Etsuro¹⁾ and JITOUSONO Takashi¹⁾

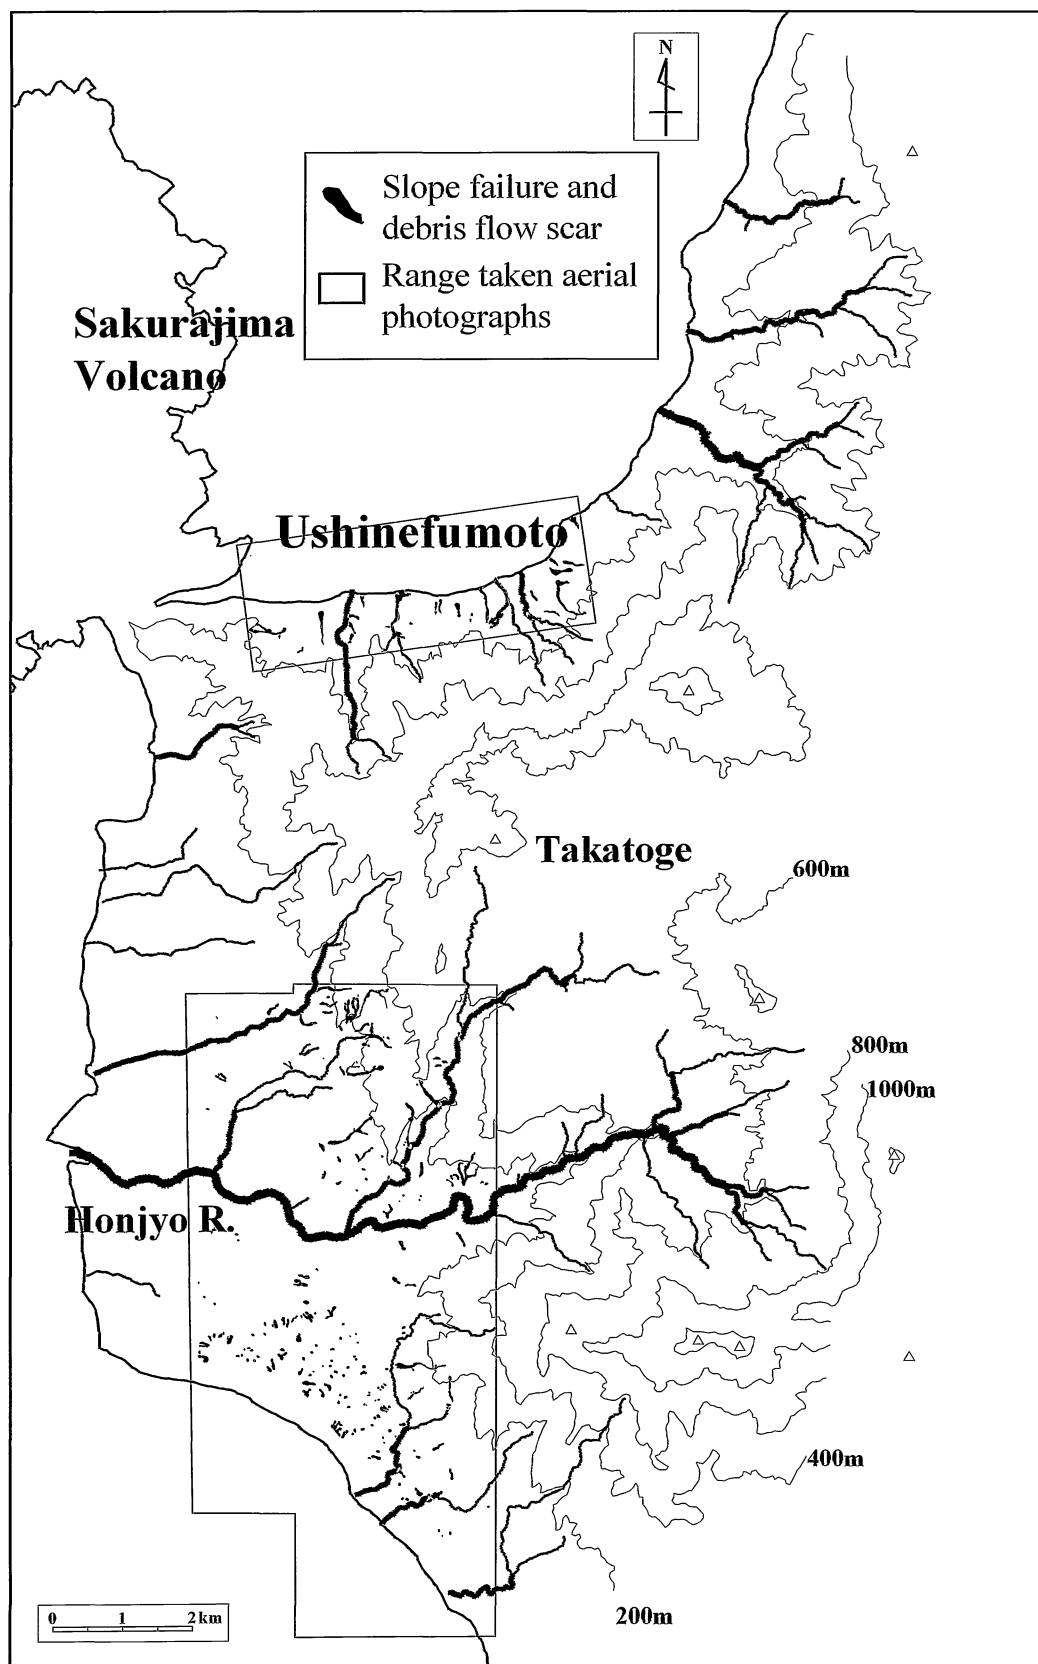
Fig. 3 shows a chart of slope failures and debris flow scars made up from aerial photographs taken after typhoon Nabi within the ranges noted in Fig. 1. **Fig. 4** shows a chart of slope

Fig. 3 Chart showing the distribution of slope failures and debris flow scars made up from aerial photographs taken after typhoon Nabi and within the ranges enclosed with a solid line in Fig. 1.

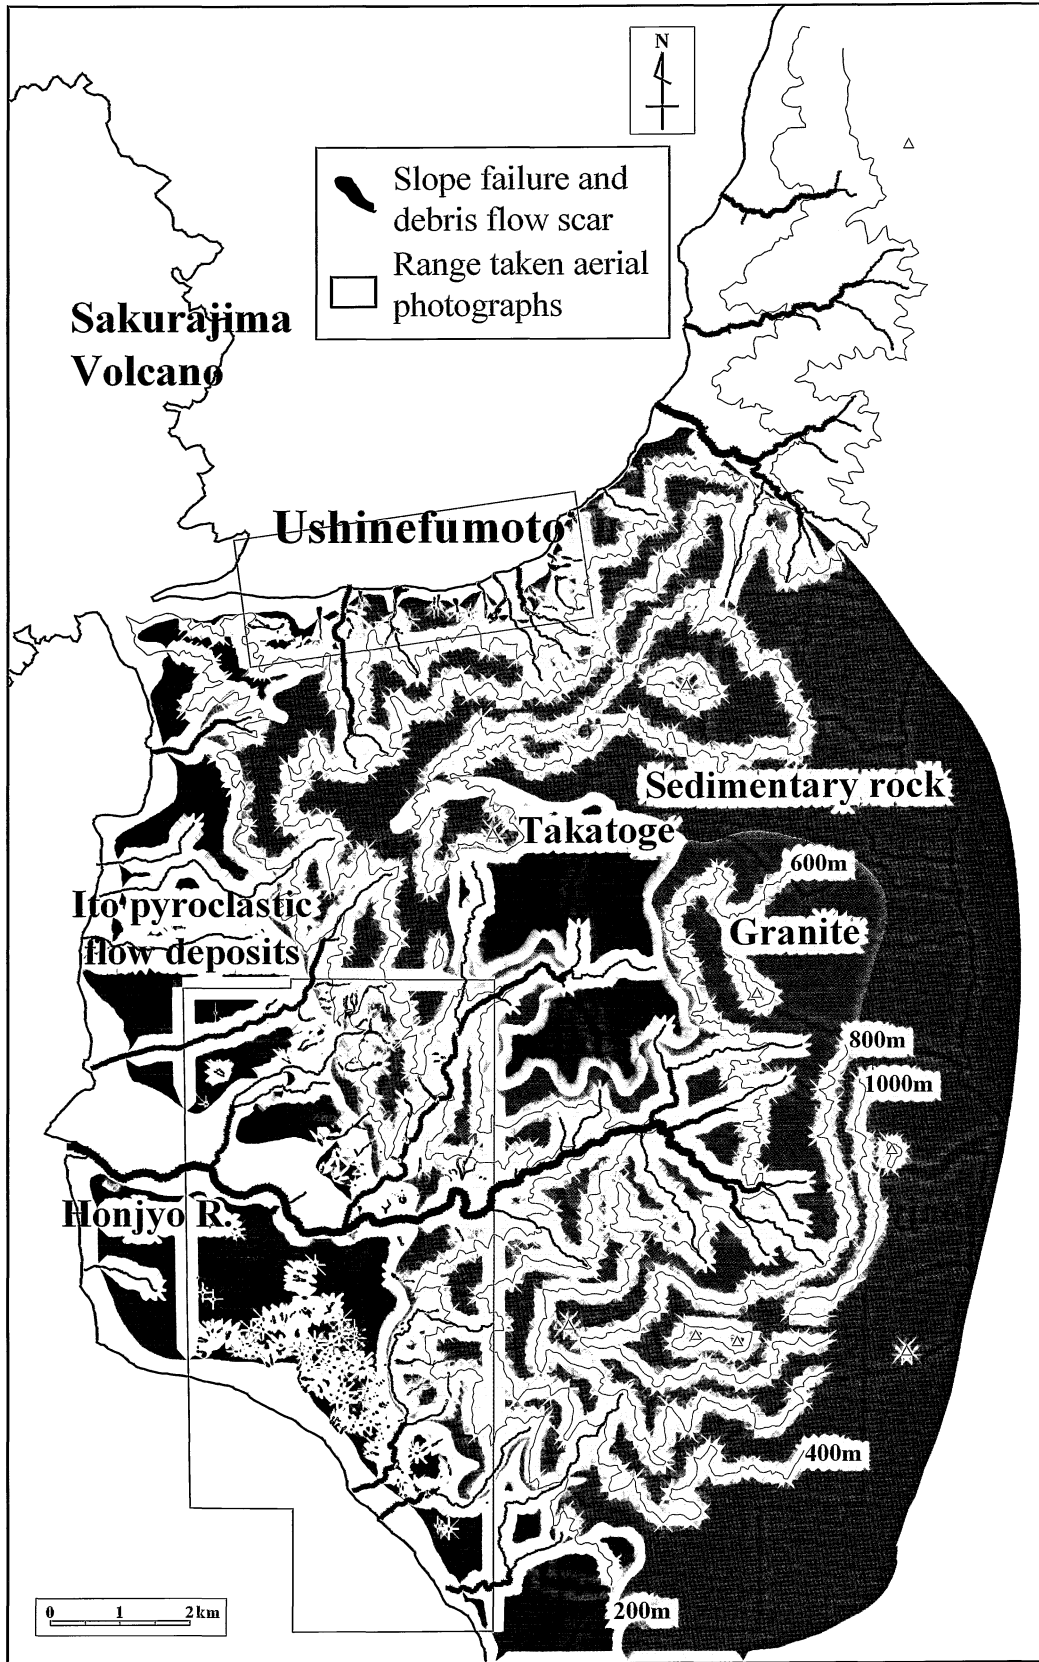
failures and debris flow scars made up from a combination of aerial photographs taken after typhoon Nabi within the ranges noted in Fig. 1 and the superficial geological map. 254 slope failures were detected within the ranges; 171 were generated on slopes consisting of Ito pyroclastic flow deposits, 75 on slopes consisting of sedimentary rock, and 8 on slopes consisting of granite. Many failures were on steep slopes, and debris flows were seen to have occurred among them.

Fig. 4 Chart of the distribution of slope failures and debris flow scars made up from a combination of aerial photographs taken after typhoon Nabi and the superficial geological map.

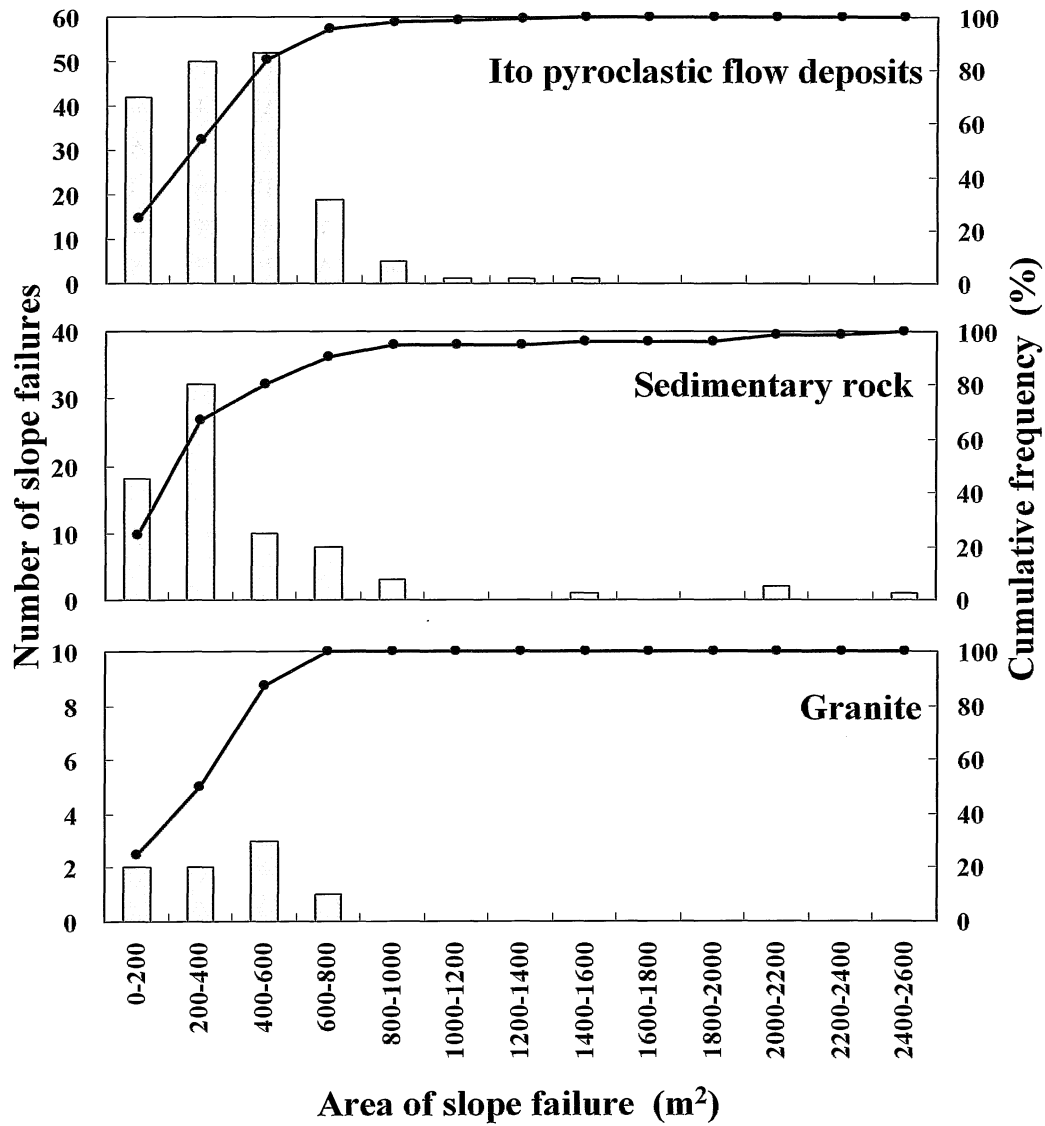
The area of a slope failure due to an individual slope failure was calculated from the chart of the slope failure scars. **Fig. 5** shows frequency distributions of areas of slope failures for each geological division within the noted ranges. About 80 percent of the slope failure areas were less than 600 m².

Fig. 5 Frequency distributions of area of slope failure for each geological division within the ranges enclosed with a solid line in Fig. 1.

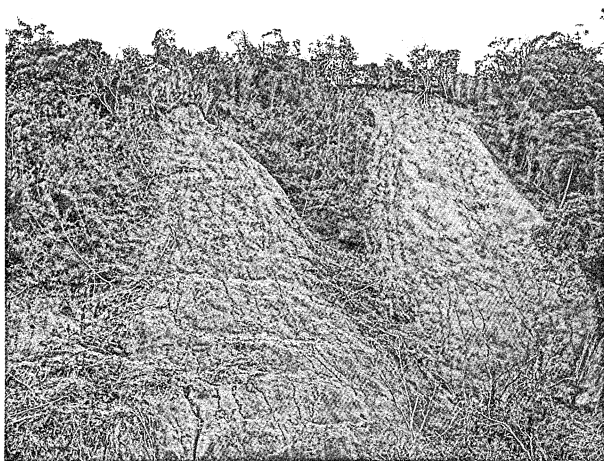
The area of slope failures generated on slopes consisting of Ito pyroclastic flow deposits ranged from 27 m² to 1,487 m², with an average of 390 m². The main types of erosion and slope failures in Ito pyroclastic flow deposits were shallow landslides resulting from infiltration of rain water into slopes (**Fig. 6**), failures occurring on the shoulder reaches of a cutting slope, and the upper reaches of slope failure scars resulting from infiltration of rain water into slopes.

Fig. 6 State of a shallow landslide generated on a Ito pyroclastic flow deposit slope.

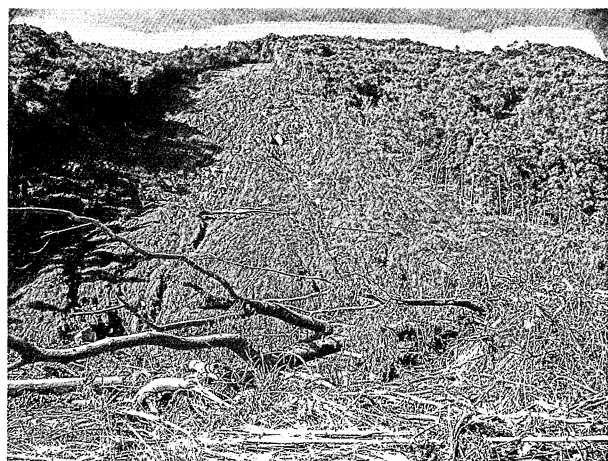
The areas of slope failures generated on slopes consisting of sedimentary rock ranged from 21 m² to 2,572 m², with an average of 437 m². The main types of erosion and slope failures in sedimentary rock were shallow landslides resulting from the infiltration of rain water into slopes (**Fig. 7**), deep-seated landslides resulting from groundwater between sedimentary rock, and the volcanic ash and volcanic pumice layer combined with an influx of rain water (**Fig. 8**). A part of the sedimentary rock has weathered due to the effect of groundwater. The area of slope failure caused by deep-seated landslides was above 2,000 m². Deep-seated landslides showed a large value compared with other types of erosion and slope failures within the noted ranges. This type of slope failure caused a large-scale sediment-related disaster and four deaths in Tarumizu City (Taniguchi et al., 2005).

Fig. 7 State of a shallow landslide generated on a sedimentary rock slope.

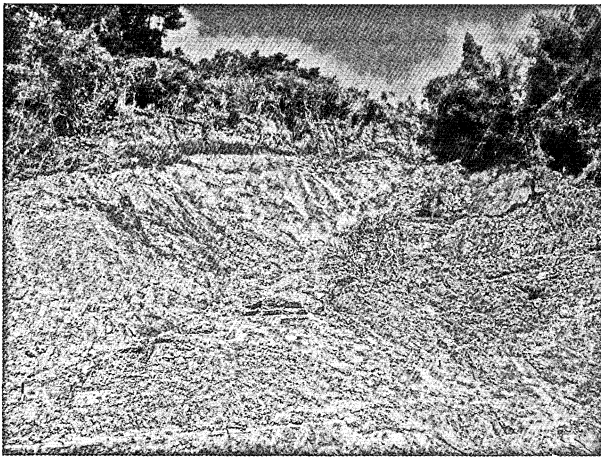
Fig. 8 State of a deep-seated landslide generated on a sedimentary rock slope.

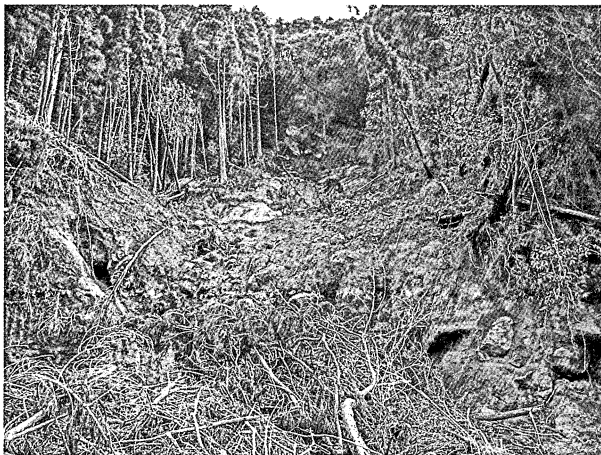
The areas of slope failures on granite ranged from 101 m² to 670 m², with an average of 357 m². The main types of erosion and slope failures were the same as those on Ito pyroclastic flow deposits (**Fig. 9**).

Fig. 9 State of a shallow landslide generated on a granite slope.
