Features of Slope-Movements due to Heavy Rainfalls in the SHIRASU Region of Southern Kyushu

Motohisa HARUYAMA

ABSTRACT

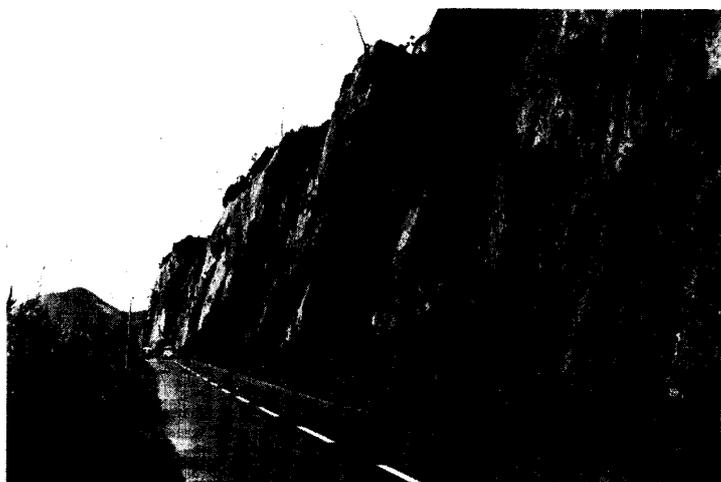
Shirasu has a structural arrangement that bestows on it considerable strength in the undisturbed condition, and at its natural moisture content, it is possible for it to form a steep slope and cliff as shown in Photo 1. The strength in natural state seems to be caused by intergranular friction and interlocking of grains, accompanied with some cementing binder or with welding at the grain contacts (YAMANOUCHI and HARUYAMA, 1969; YAMANOUCHI and MURATA, 1973). But when subjected to a flow of water, Shirasu is extremely weak in the action of flowing water. In the analyses of many engineering problems in Shirasu, the largest trouble is caused by an erosive property. Accordingly, any addition of water would cause the grains

Photo 1. Cliff of Shirasu deposits.

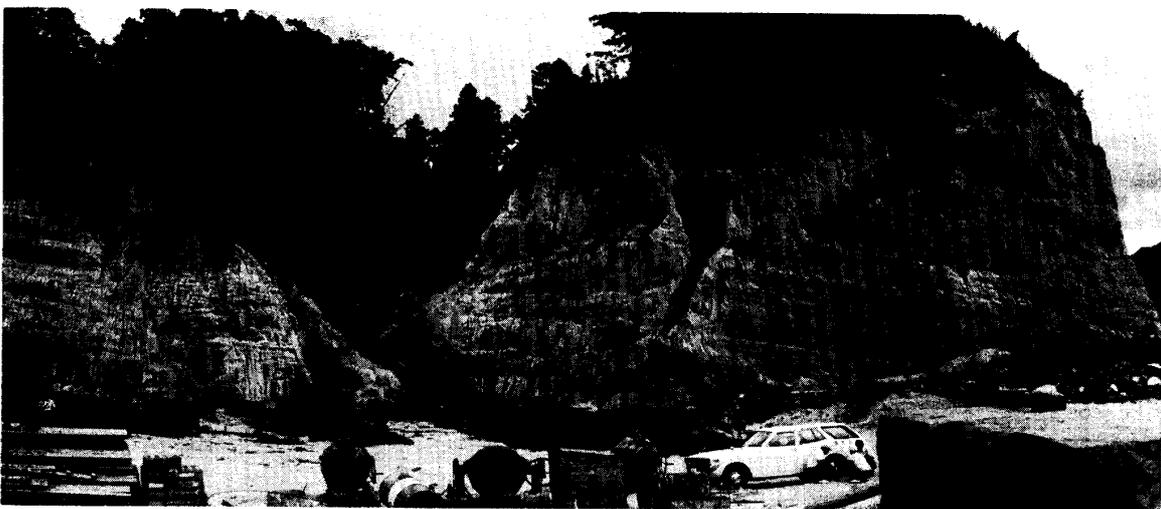
Generally speaking, Shirasu is very susceptible to erosion occasioned by the action of flowing water on slope. Hard Shirasu, however, is resistant to erosion. Areas where Shirasu ground is left unprotected or is left stripped of its topsoil by the sliding of surface-layer, as explained next, are most susceptible to sheet erosion. Sheet erosion is led inevitably to rill erosion and advanced stage, gully erosion. Erosions have damaged sloping land throughout the Shirasu deposits. Of all the erosions, gully erosion is most active and dangerous. During the gully development, the gully head has progressed toward the upper end of watershed. Since Shirasu is easily eroded, gully cross-section is to be turned into a deep glen of U-shape. Under such condition gully tends to develop a vertical wall resulting from cavings and collapses of slopes. Rill and

Photo 2. Rill erosion.

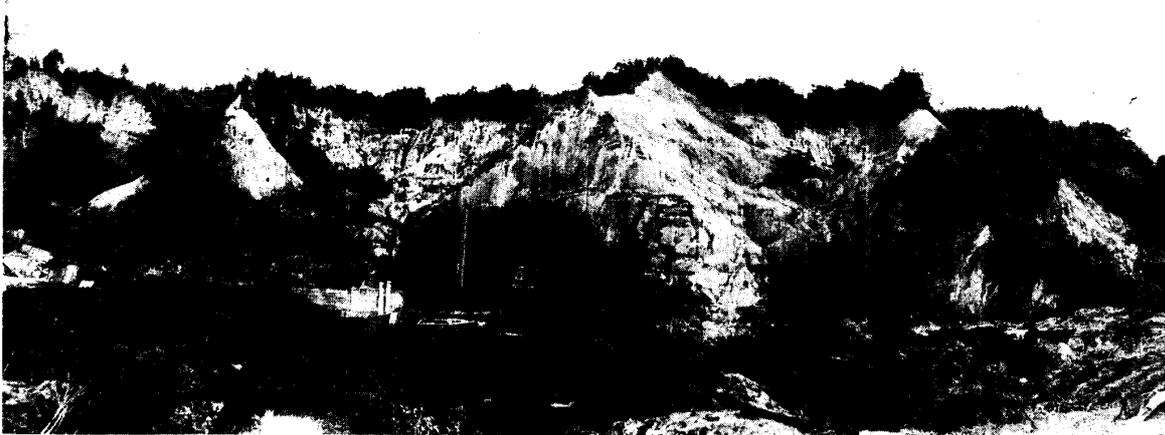
weathering materials of bedrock. This type occurs on the hill-slopes dipping 30 to 60 degrees and is especially frequent on the hill-slopes of 50 to 60 degrees. The topsoils may slide down in a thickness from several tens centimeters to some one meter. As a consequence of removal of topsoil, exposed Shirasu suffers from water erosions as described above, and the successive erosions often enlarge the scale of slope-failures. Topsoil slides on Shirasu deposits are the most frequent mass-movements in the basic types of slope-movements in the Shirasu region. The typical failure of hill-slopes due to this type is shown in Photo 4. These sliding failures of superficial deposits seem to take place as the results of the following phenomena: the increase in the weight of soil itself caused by the infiltrated water in a rainfall, the lowering of shearing resistance caused by soil saturation, the development of excessive pore water pressure, the occurrence of intermediate flow in the topsoil layer, and others.

Photo 4. Topsoil slides.

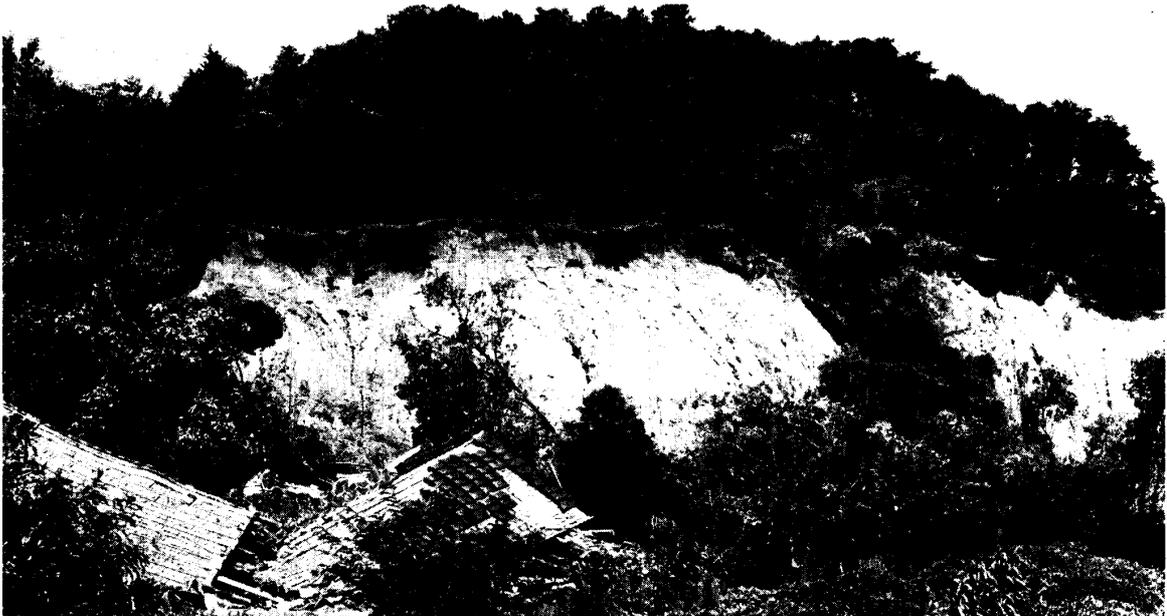
Topsoils on the upper part of cliffs and cutting-slopes of Shirasu fall down, and consequently the bared Shirasu beneath topsoils suffers from erosions by waterflow on slope. Essentially topsoil falls probably take place out of the same causes as topsoil

slides. But topsoil falls apparently differ from topsoil slides in getting no support from side. The hill-slopes where there are tall trees on the ledge of cliffs occasionally cause these fallings because trees are swayed by the windstorm. The failure of slope due to this type is shown in Photo 5.

Photo 5. Topsoil falls.

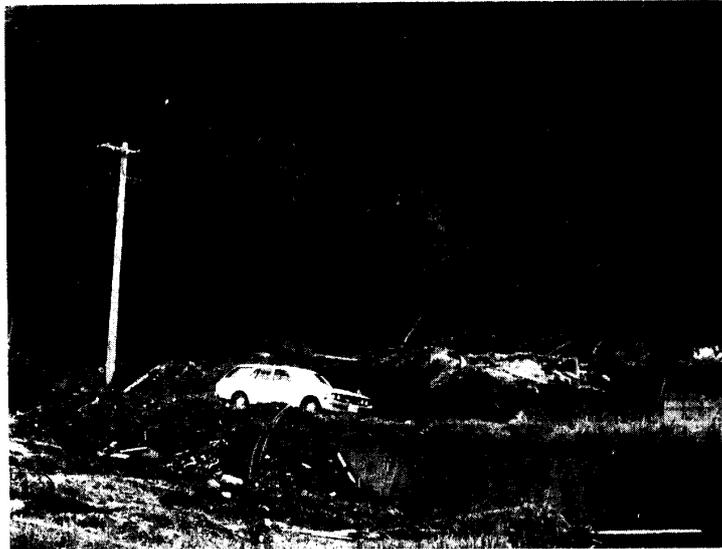
This frequently occurs at a place where the foot of hill-slopes has been cut off and a fountain gushes out. Piping is caused by permeating-water or fissure-water squeezed along the boundary plane of beds which are different in Shirasu strength or in permeability. If the seepage-water-pressure becomes effective, ground-water concentrates in some weak points produced by the heterogeneity of the Shirasu deposits, often issuing from the foot of cliffs, the surface of slopes, the boundary plane of deposits, or from the fissures and joints in Shirasu deposits. If such phenomena occur, fine grains of Shirasu are washed out by the subsurface-erosion due to action of water, leaving some pipe-like water channel in Shirasu deposits, and this finally is led to collapse of slopes. The occurrence of failures of hill-slopes due to piping is especially frequent in layers of decomposed and secondary Shirasu. The examples of piping are shown in Photo 6.

Photo 6. Slope failure due to piping in the slope of decomposed Shirasu.

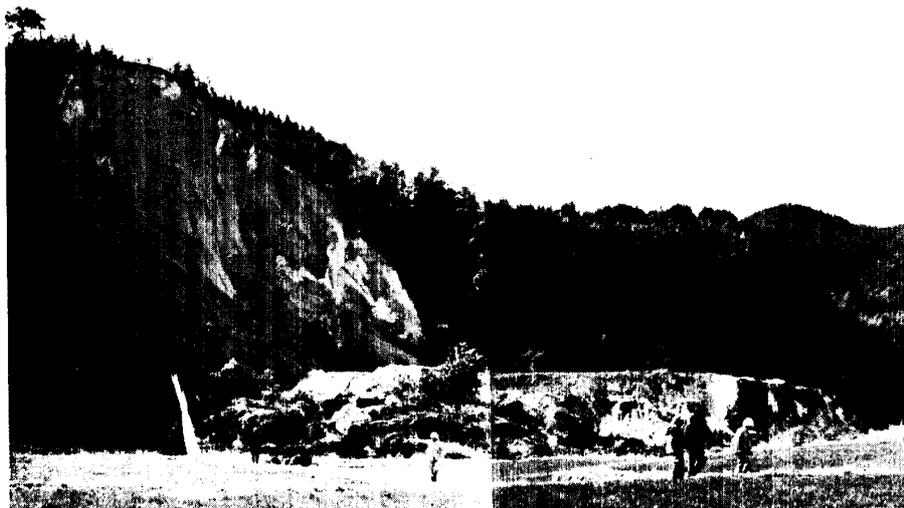
the reason is probably due to the time-lag in the rise of groundwater level, based on the permeability of Shirasu. Photo 7 shows the rotational slide that initially occurred in hill-slope of proper Shirasu at a clear weather after a period of extraordinarily heavy rainfall. Therefore, there is no mark of the water erosion peculiar to Shirasu on the exposed slope of Shirasu hill.

Photo 7. Rotational slides in hill-slope of proper Shirasu.

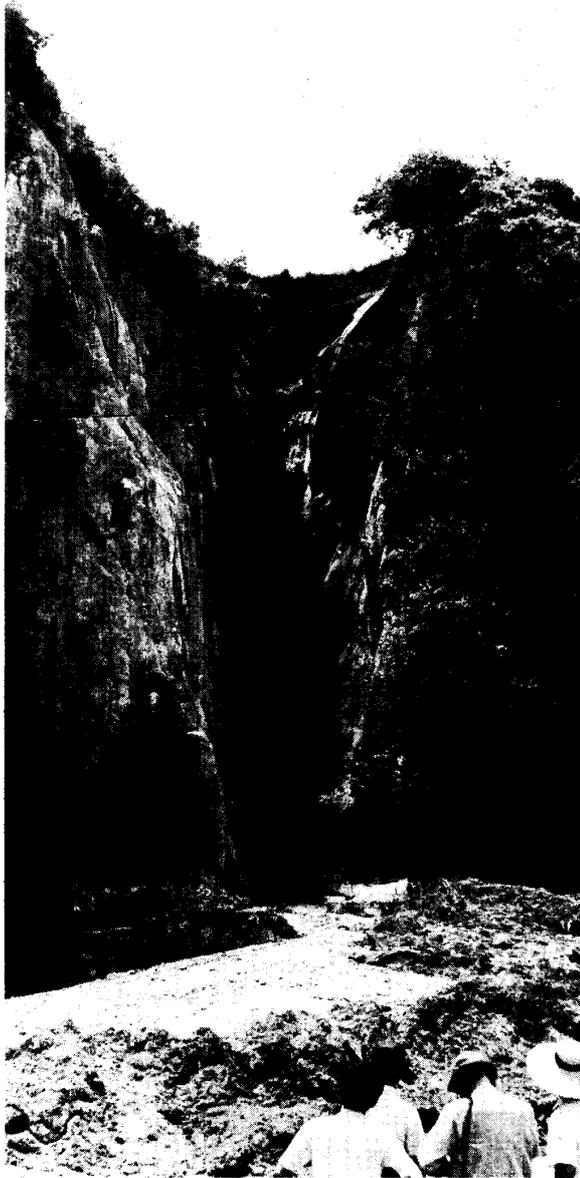
At the marginal part of Shirasu plateau waterfalls are often formed in a period of heavy rainfall by the concentrated falling of overland water and by that of the overflowed water from gutters. Thus waterfall develops a plunge pool at its bases which

Photo 8. Waterfall erosion.

are cut back under the fall, and it brings forth scouring below the water surface and caving of the wall above. Then collapses in the overhung cliffs may be caused by the loss of supporting capacity of Shirasu itself and by the development of tension cracks behind the cliff-crest. Waterfall erosion at the gully head causes the upstream movement of the head, and develops a deeply erosion ravines. Photo 8 shows the collapse of this type in Shieasu hill.

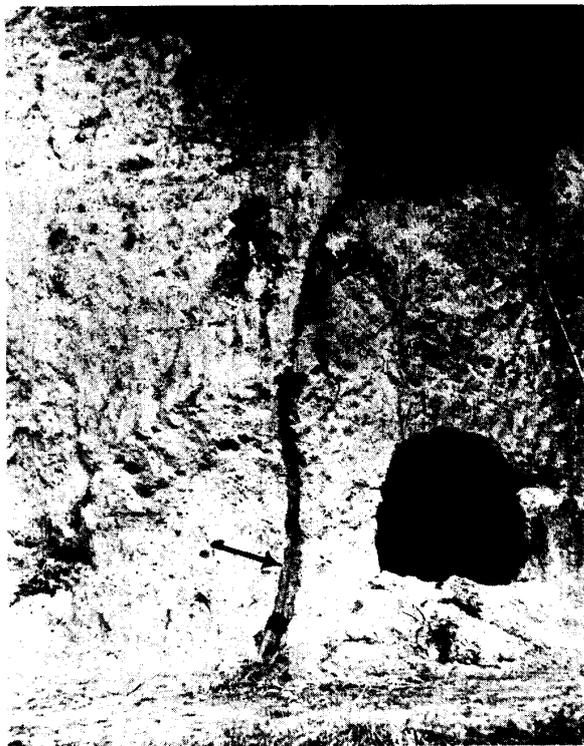
Photo 9. Joint filled with clayey soil.

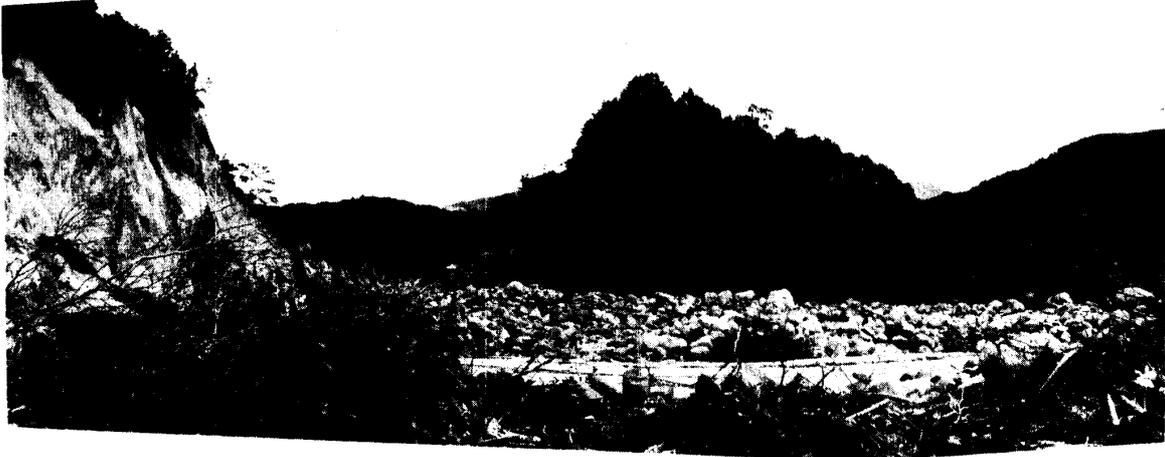
The term debris flows designates a swift flow of pumiceous sand and mud heaped up on ravine bed or that of degraded slope debris oversaturated by rainwater. This also occurs in some weathering mantles of tuff or andesite; and when this occurs in Shirasu deposits a peculiar appearance as if the whole ground were liquated may be seen. A typical failure due to debris flows is shown in Photo 13. The place in Photo 13 was proper Shirasu hill and paddy field before the damage due to debris flows, but in only a single night, a complex of Shirasu and rocks of about half a million cubic meters in volume was washed-out away by debris flows accompanied with downward erosion and lateral corrosion, and consequently a short-cut was formed. The heavy rainfall brought about this damage resulted from the typhoon on Aug. 3, 4, and 5, 1971 (Table 2).

Photo 13. Debris flows accompanied with erosion and corrosion.
