# Damage caused by typhoon Nabi to slopes bordering forest roads in the Takakuma Experimental Forest, Kagoshima University, in September 2005

In order to clarify the nature and scale of the damage caused by typhoon Nabi in September 2005 to the slopes bordering the forest road through the Takakuma Experimental Forest at Kagoshima University, thirty five slopes bordering the road, damaged by typhoon Nabi, were investigated. Characteristic results were as follows:

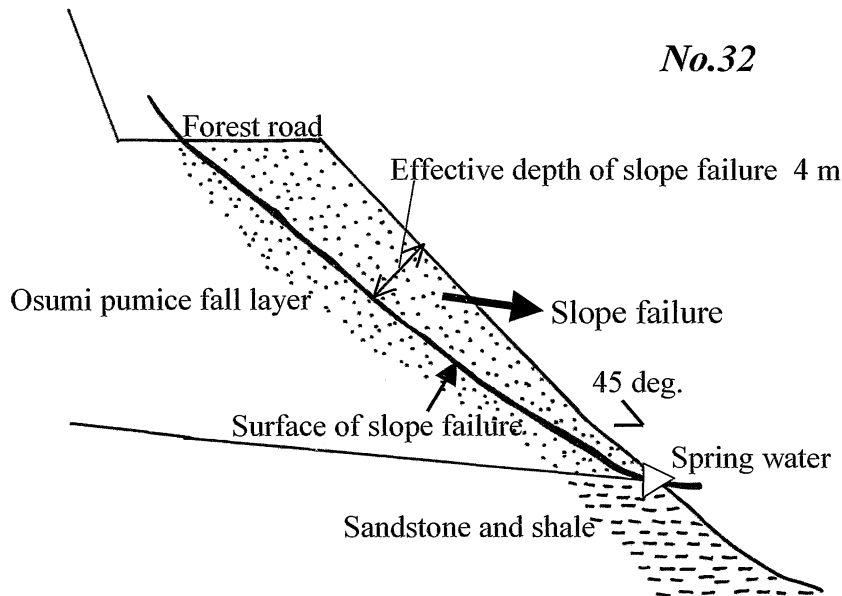
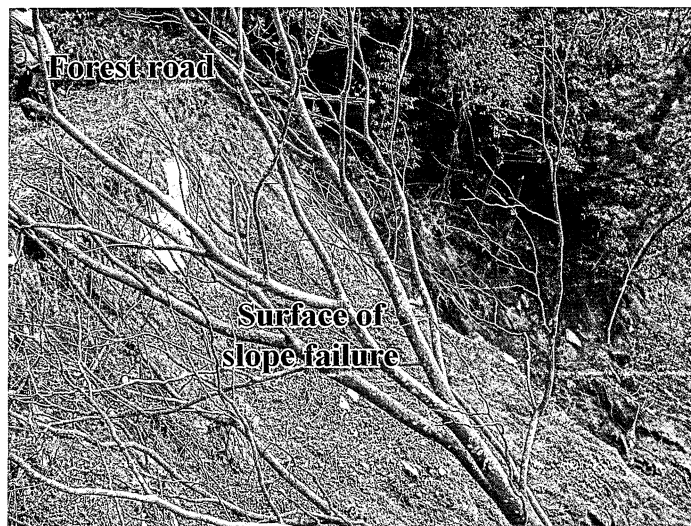
Fig. 2 Pattern diagrams and state of erosion and slope failure observed at sample point No.32.

**Fig. 2** shows pattern diagrams and key features of the erosion and slope failure observed at sample point No.32 in Fig. 1. This slope failure was a slope failure occurring on the downhill side of the forest road as a result of groundwater between the bedrock (sandstone and shale) and the pyroclastic fall deposits (Osumi pumice fall layer) being augmented by an influx of rain water. The width of the slope failure was 20 m, with a slope length of 20 m, and an effective depth of slope failure of 4 m. The area of slope failure was, therefore, 400 m<sup>2</sup> and the sediment yield due to slope failure was 1,600 m<sup>3</sup>. The magnitude demonstrated by this slope failure had the highest value of any within the study area.

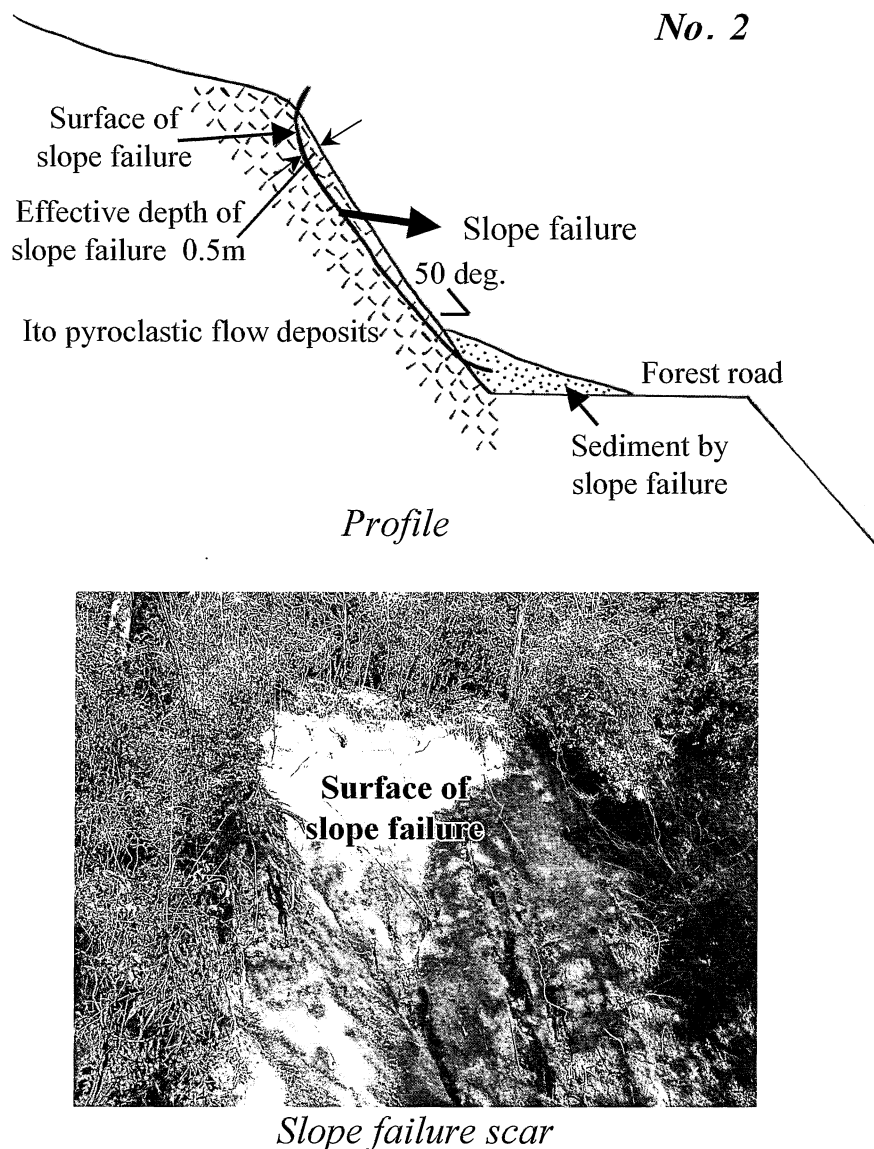
Fig. 3 Pattern diagrams and state of erosion and slope failure observed at sample point No.2.

**Fig. 3** shows pattern diagrams and key features of the erosion and slope failure observed at sample point No.2 in Fig. 1. This

slope failure was a shallow landslide resulting from the infiltration and concentration of rain water into surface soil in the cutting slope. The width of slope failure was 5 m, with a slope length of 8 m, and an effective depth of slope failure of 0.5 m. Thus, the area of slope failure was 40 m<sup>2</sup>, and the sediment yield due to slope failure was 20 m<sup>3</sup>. This type of slope failure was on a small scale, when compared with others within the study area.

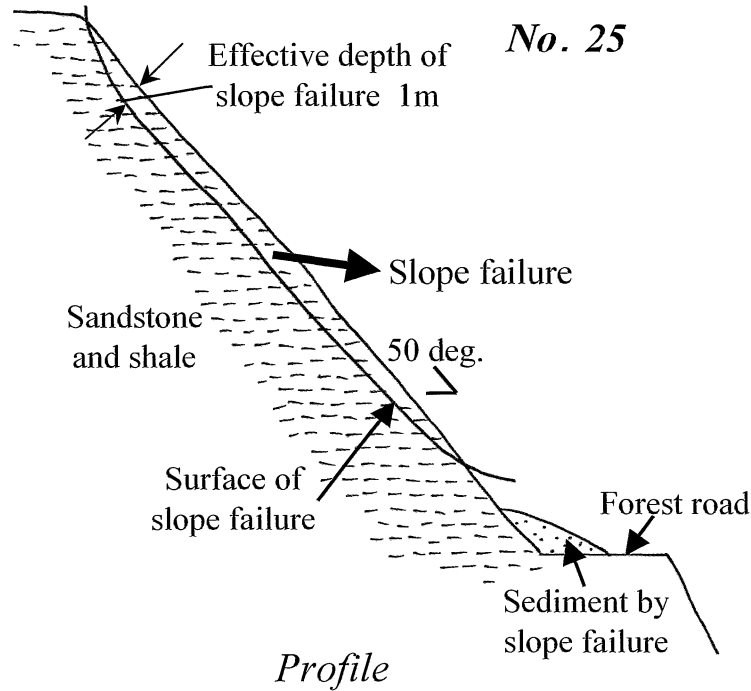
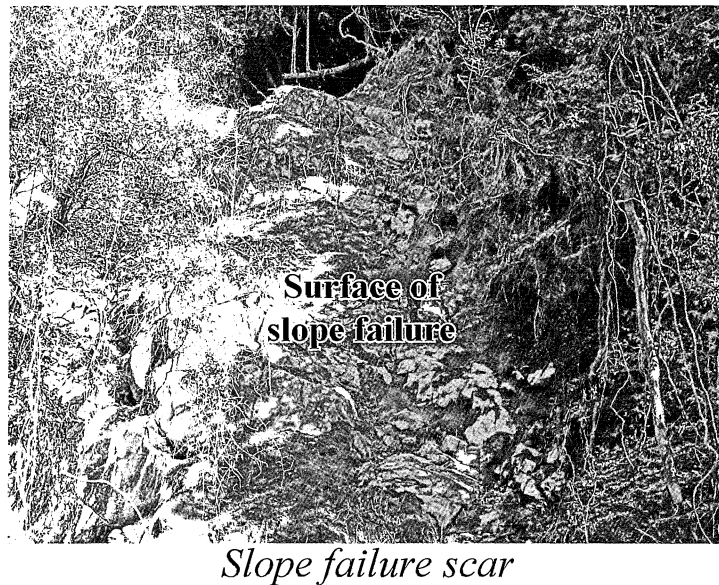
Fig. 4 Pattern diagrams and state of erosion and slope failure observed at sample point No.25.

**Fig. 4** shows pattern diagrams and key features of the erosion and slope failure observed at sample point No.25 in Fig. 1. This slope failure was a shallow landslide resulting from the infiltration and concentration of rain water into surface soil in the natural slope. The width of slope failure was 10 m, with a slope length of 25 m, and an effective depth of slope failure of 1 m. Thus, the area of slope failure was 250 m<sup>2</sup>, and the sediment

yield due to slope failure was 250 m<sup>3</sup>. The magnitude of this slope failure was relatively large, when compared with other shallow landslides within in the study area.

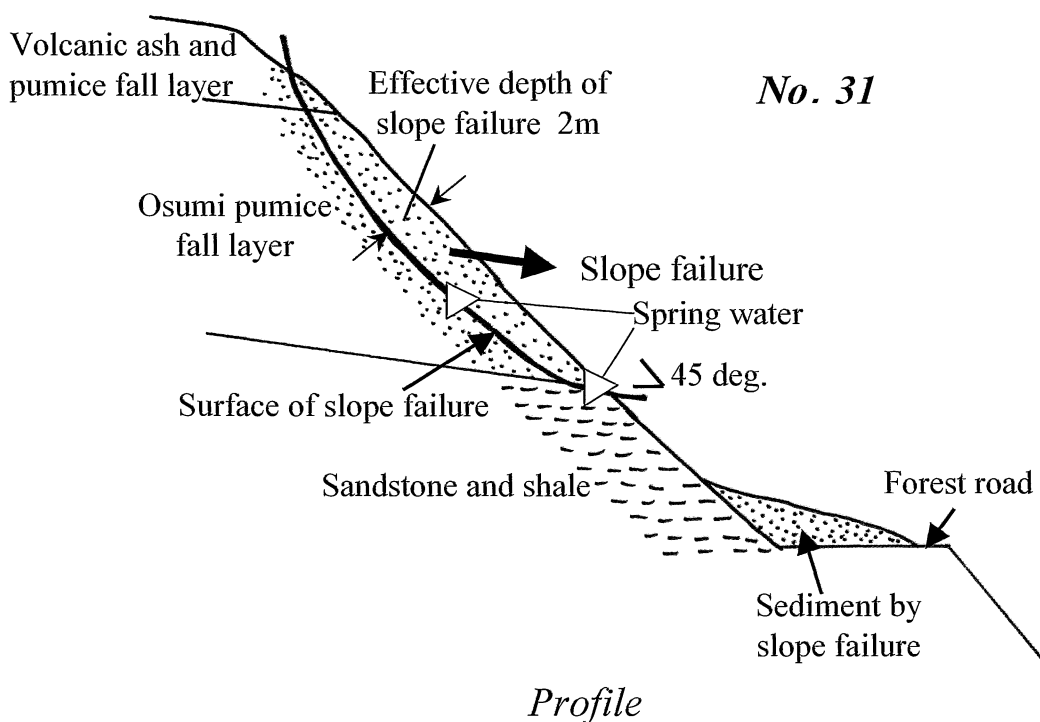
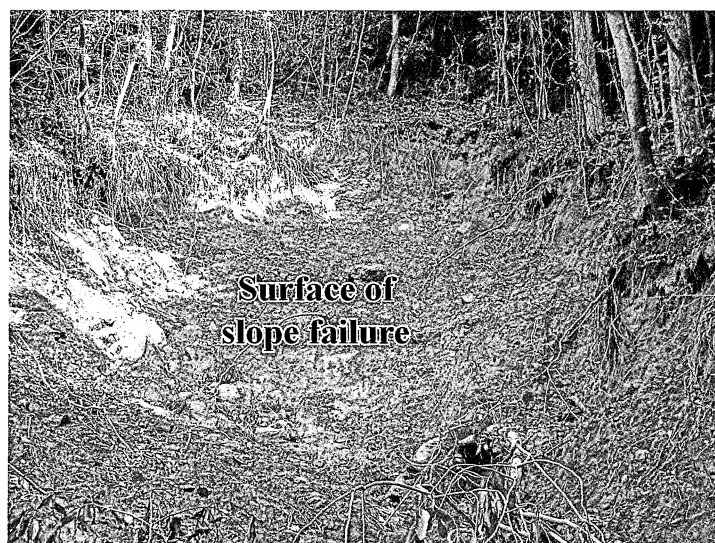
Fig. 5 Pattern diagrams and state of erosion and slope failure observed at sample point No.31.

**Fig. 5** shows pattern diagrams and key features of the erosion and slope failure observed at sample point No.31 in Fig. 1. This slope failure was a deep-seated landslide resulting from groundwater between the bedrock (sandstone and shale) and the overlying pyroclastic fall deposits (Osumi pumice fall layer) augmented by an influx of rain water. The width of slope failure

was 20 m, with a slope length of 16 m, and an effective depth of slope failure of 2 m. Thus, the area of slope failure was 320 m<sup>2</sup>, and the sediment yield due to slope failure was 640 m<sup>3</sup>.

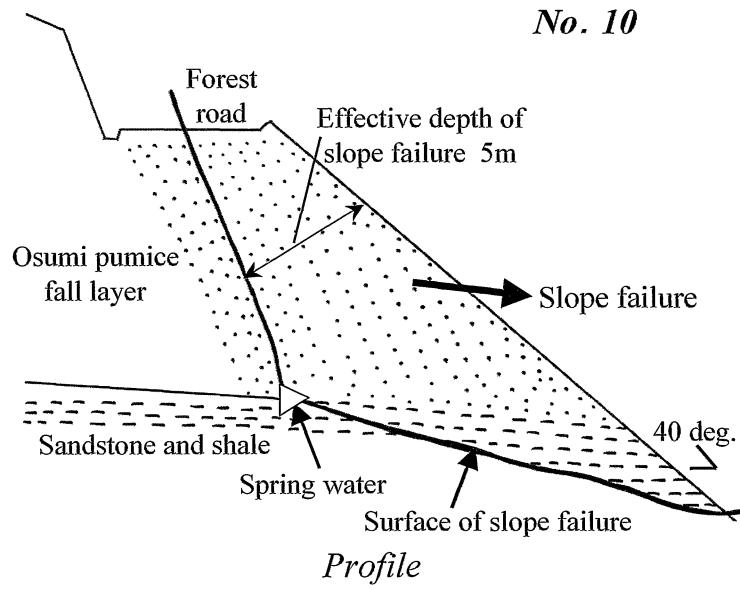
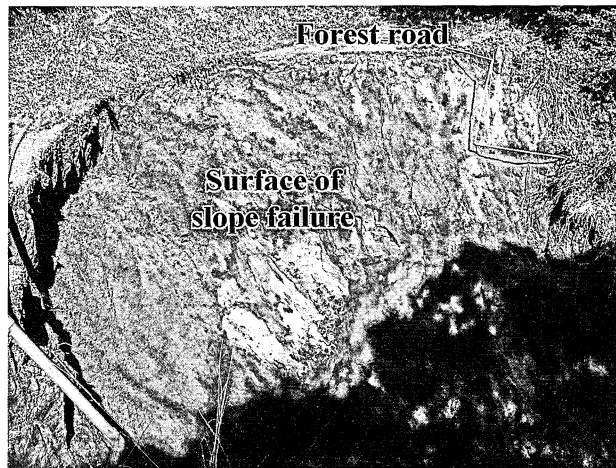
Fig. 6 Pattern diagrams and state of erosion and slope failure observed at sample point No.10.

**Fig. 6** shows pattern diagrams and key features of the erosion and slope failure observed at sample point No.10 in Fig. 1. This slope failure was a failure of the subbase and subgrade bearing body of the forest road itself, as a result of groundwater between the bedrock (sandstone and shale) and the pyroclastic fall deposits (Osumi pumice fall layer) augmented by an influx of rain

water. The width of slope failure was 15 m, with a slope length of 15 m, and an effective depth of slope failure of 5 m. Thus, the area of slope failure was 225 m<sup>2</sup>, and the sediment yield due to slope failure was 1,125 m<sup>3</sup>.

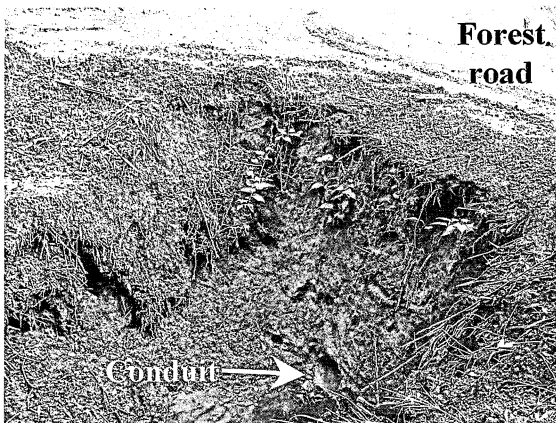
The one remaining type of forest road damage, not illustrated above, is that due to the clogging of conduits and the partial failure of forest roads as a result of inundation by sediments due to debris flow, as observed at sample point No.5 in Fig. 1 (Fig. 7).

*The clogging of conduit*

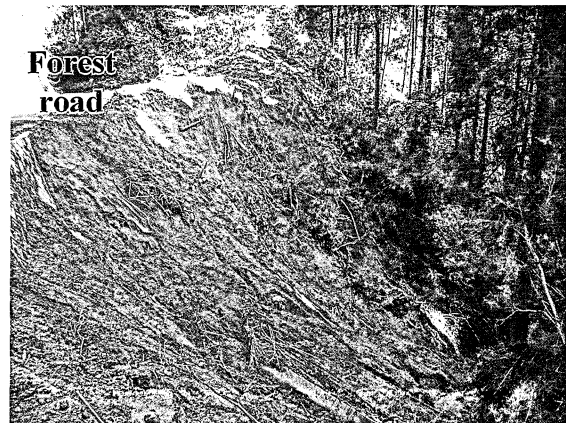
*The partial failure of forest road as a result of inundation by sediments due to debris flow*
