Slope failures and movement of driftwoods caused by typhoon Nabi in the Nakamata River Basin in Kagoshima Prefecture, Tarumizu City, in September, 2005

TERAMOTO Yukiyoshi¹¹, SHIMOKAWA Etsuro¹¹, JITOUSONO Takashi¹¹ and TAKAOKA Atsuko¹¹

1) Department of Environmental Sciences and Technology, Faculty of Agriculture, Kagoshima University, Korimoto 1-21-24, Kagoshima 890-0065

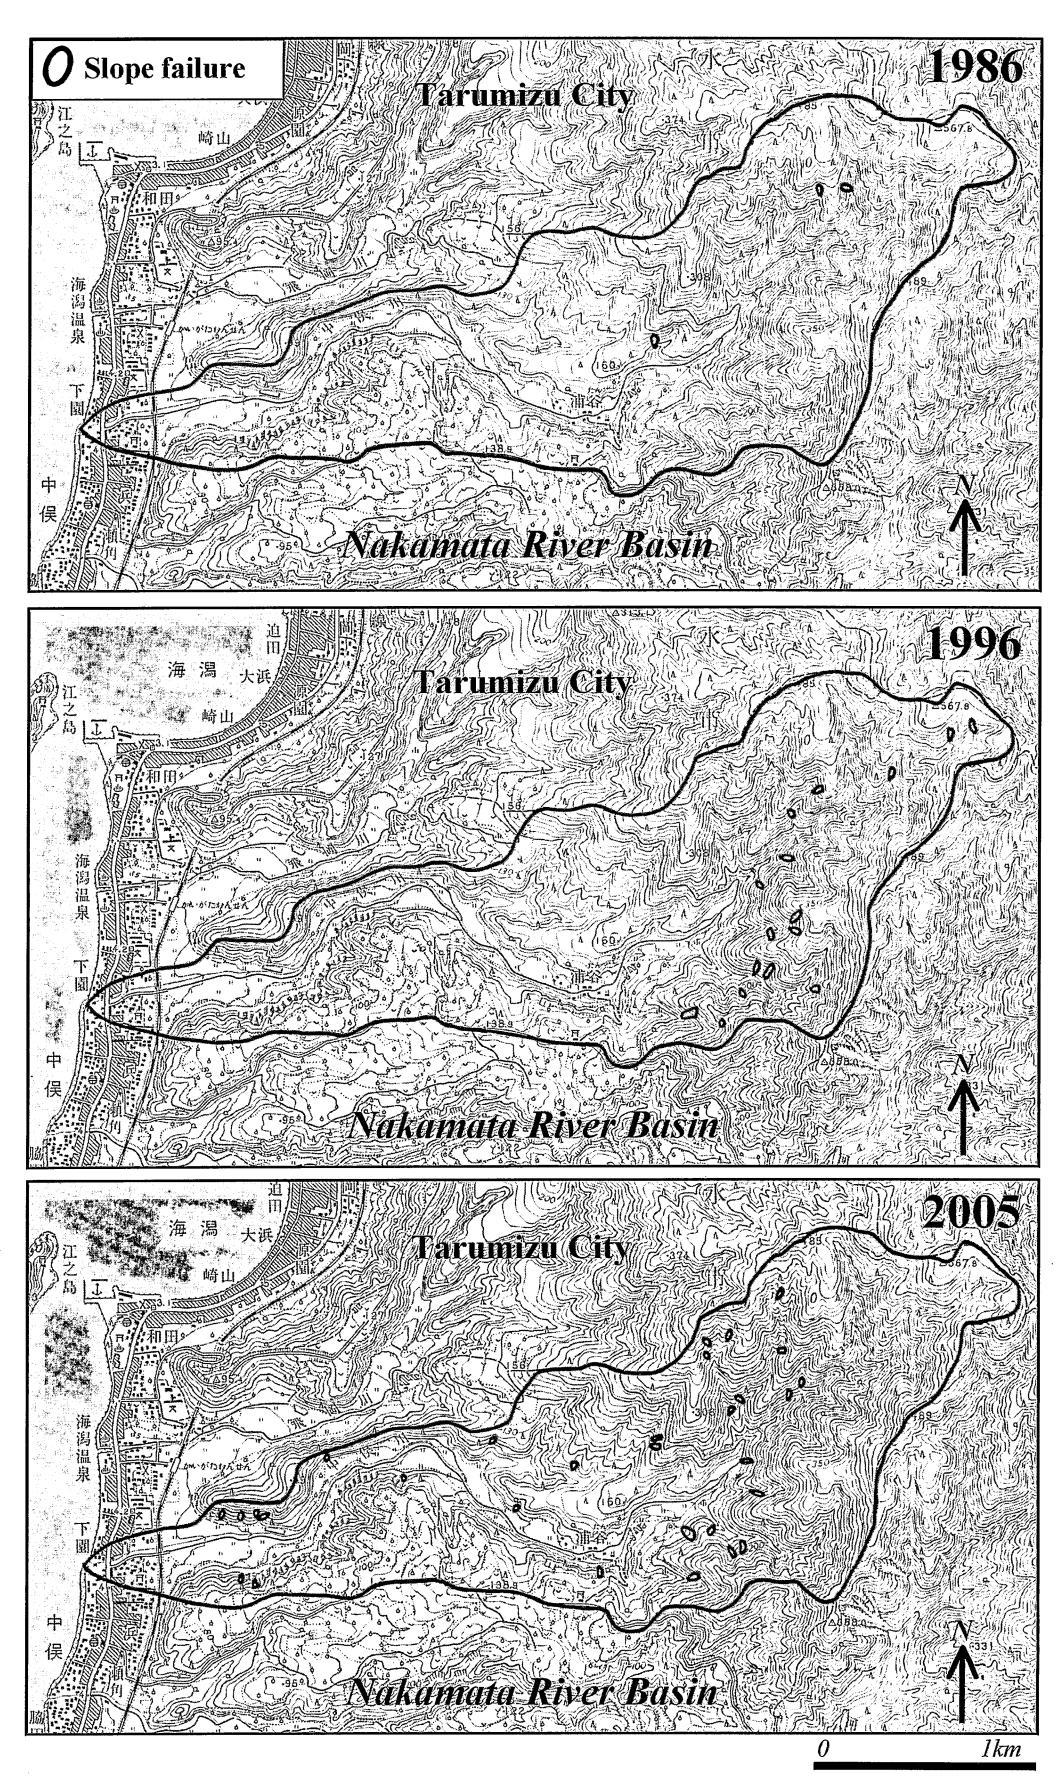
Fig. 2 Distribution charts of slope failure scars based on aerial photographic interpretation.

Fig. 2 shows distribution charts of the slope failure scars. Since the slope failure scars which are common to each figure are plotted respectively not to be duplicate, these scars in the figure are proper ones in every period.

Three slope failures were detected. A slope failure is distributed in the middle reaches region and another in the upper stream region in the basin. All were shallow landslides. The area of slope failure ranged from 125 m² to 625 m², with an average of 313 m². The heavy rainfall immediately before 1986 when the aerial photograph was taken includes the heavy rainfall due to typhoon No.13 (maximum daily rainfall of 115 mm from August 25th to 26th 1984) and the heavy rainfall from August 30th-31st 1985 (maximum daily rainfall 186 mm). (2) Distribution chart of slope failure in 1996

There were sixteen detected slope failures, generated over the course of eleven years from 1986 to 1996. These was generated in slopes consisting of Ito pyroclastic flow deposits and sandstone and shale in the basin, and most are shallow landslides.

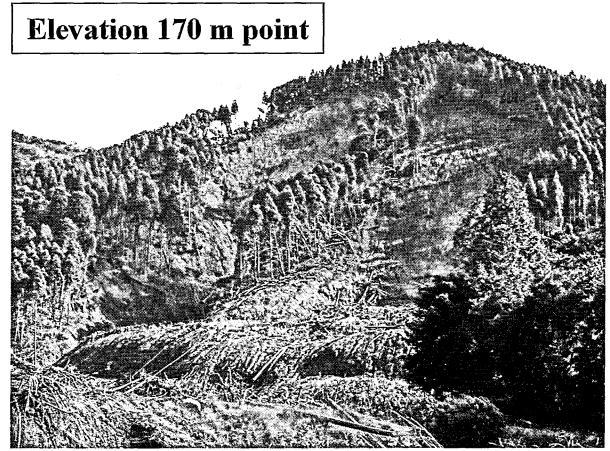
Fig. 3 Slope failures caused by typhoon Nabi.

The number of slope failures generated by typhoon Nabi was confirmed by the field investigation to be thirty. Slope failures were generated on slopes consisting of Ito pyroclastic flow deposits and a sandstone and shale from the upper stream to downstream region in the basin. All were shallow landslides (**Fig. 3**). The area of slope failure ranged from 25 m² to 2,600 m², with an average of 467 m². The maximum daily rainfall was 34 mm, and the total rainfall was about 630 mm from 4th to 6th September, 2005 (Takatoge automated meteorological data acquisition system, 1986-2005).

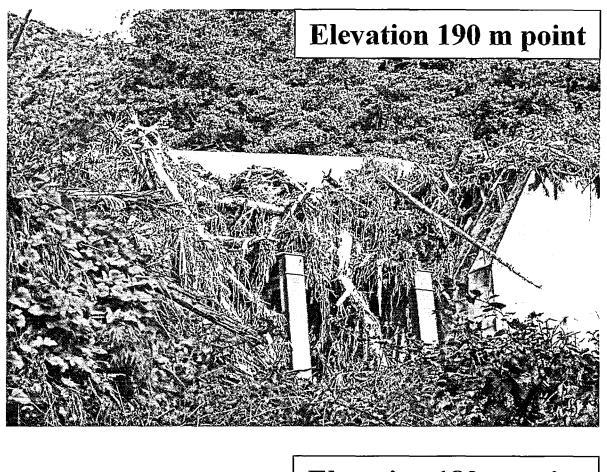
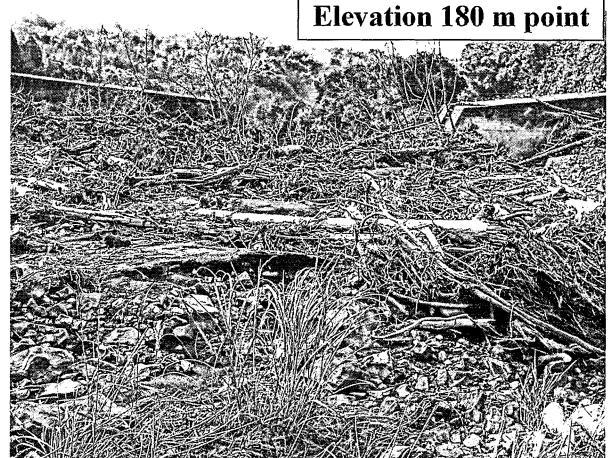
Fig. 4 Sediment that accumulated against the check dams and driftwoods caught by slope failures in the check dams.

In addition, the amount of sediment that accumulated against the check dams (Fig. 1, **Fig. 4**) constructed after the sedimentrelated disaster in 1991, that is, the sediment discharge was calculated, is based on the result of field surveying executed in November, 2005. During the 15 years from 1991 to 2005, the amount of sediment discharge that flowed out due to slope failures, debris and mud flows and floods was 12,010 m³/km². The yearly mean value was 800 m³/km². The sediment discharge of the remainder is thought to have accumulated in the channels

Fig. 6 shows the main distribution of the driftwoods flowing out of the Nakamata River Basin. Fig. 6 shows the situation, at the same time, of the check dams constructed after the sedimentrelated disaster in 1991 and the distribution of slope failures caused by typhoon Nabi. **Table 3** shows the total volume of driftwoods yielded by slope failures and flowing out of the Nakamata River Basin. Most of the driftwoods yielded by the slope failures generated in stream above the check dams, was supplemented by the check dams (Fig. 4).

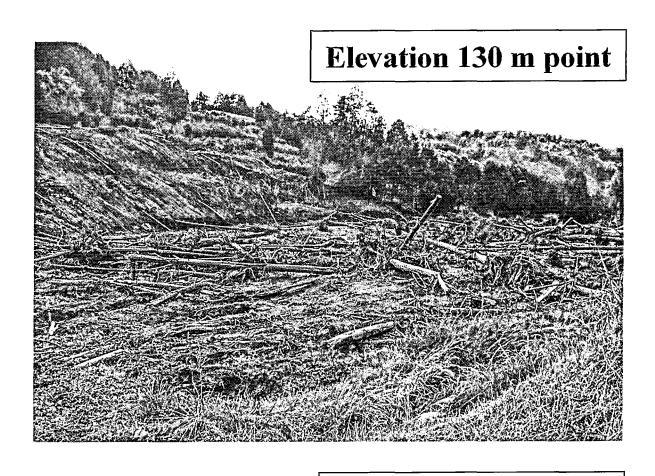
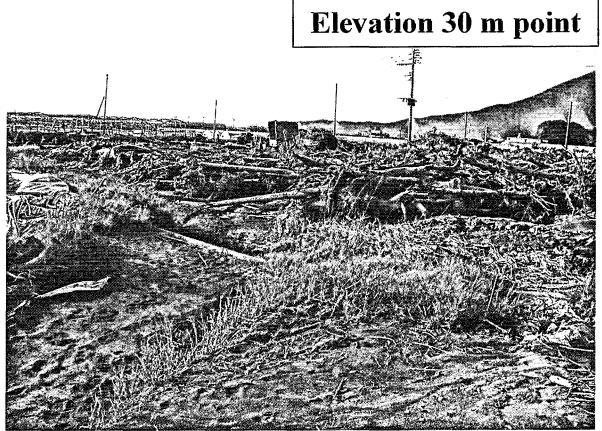
Fig. 5 Driftwoods caught the channel in the middle reaches region and around the downstream region.

Vegetation with which the slopes in the Nakamata River Basin were covered was destroyed by the slope failures generated by the heavy rainfall of typhoon Nabi. The destroyed trees flowed downstream along with other debris and mud flows in the floods. Driftwoods flowed out to sea after the check dams and channel were partially supplemented (**Fig. 5**). The basin was badly damaged by these driftwoods.

The majority of the driftwoods (Fig. 5) that were caught in the channel in the middle reaches region and the downstream region and which flowed out to the sea, came from the slope failures generated downstream of the check dams. Driftwood as produced by slope failures came not only from slopes covered with conifer but also slopes well-covered with broadleafed trees.

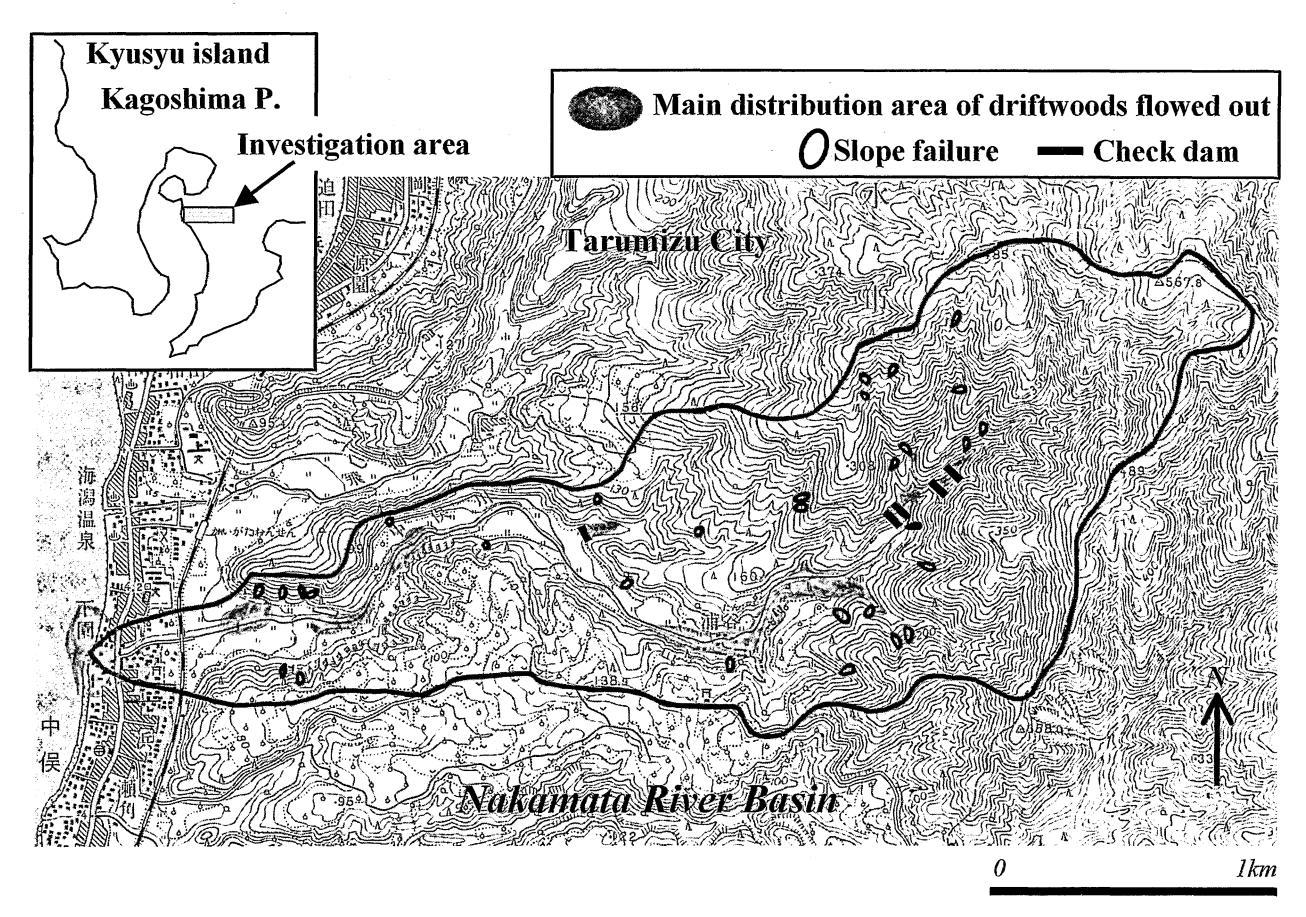
Fig. 6 The main distribution chart of driftwoods flowing out of the Nakamata River Basin based on a field investigation.

On the other hand, driftwoods other than that caught by the check dams, flowed out to the downstream region. The driftwood budget shows that 227 m³ was caught by the check dams from a total driftwood yield of 630 m³. In addition, 176 m³ was caught in the channel and 198 m³ flowed out to sea.
