## **Shoreline Erosion on a Low Coral Island in Fiji - Causes and Consequences**

James P. TERRY<sup>1</sup>

*Geography Department, The University of the South Pacific, PO Box 1168, Suva, Fiji  
and  
Kagoshima University Research Center for the Pacific Islands, Kagoshima, Japan*

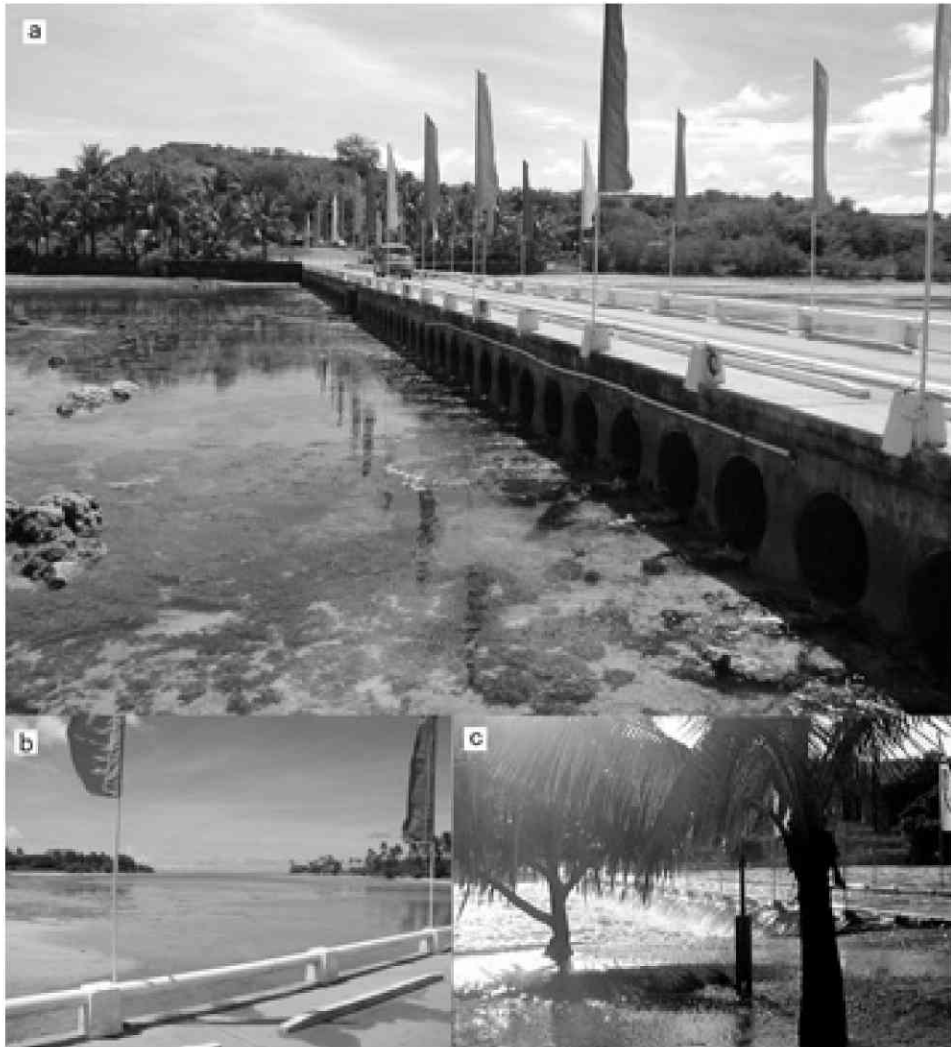
Fig. 2. a. View of the Fijian Resort causeway linking the east coast of Yanuca Island with mainland Viti Levu. b. Southern entrance of Yanuca Channel seen from the causeway. c. Significant damming effect of the causeway in storm surge conditions during tropical cyclone Paula, March 2001.

The 94 m long concrete causeway across Yanuca Channel was constructed in the mid-1960s to link the east coast of Yanuca Island with the Fiji mainland. The causeway has an 'Irish crossing' design, with a level access road built across 57 concrete culverts (Fig. 2a). There is a single open span in the centre of the causeway, in addition to the culverts, to allow the through-put of water. The causeway was built across the narrowest part of the channel, but land reclamation at each end has further reduced the channel width, increasing the constriction. Visual reconnaissance during this study indicated that the causeway design impedes water flow around the north side of Yanuca Island, so the damming effect of the structure was estimated as follows. Because the causeway structure blocks part of the channel, the dam area is equivalent to the cross-sectional area of the causeway, minus the surface area of the 'gaps' which allow water to flow through, i.e. the circular culverts and the central rectangular span. If the gaps in the structure were sufficient to accommodate the entire channel flow, then the water level on both sides of the structure should be equal. It follows that any observed difference in water level on either side of the causeway indicates the dam effect. At high tide on 14<sup>th</sup> February 2001, water level was measured simultaneously on opposite sides of the causeway at 45 equally spaced locations along its length. The average difference in water level on opposite sides was 12 cm. This equates to a causeway dam effect of approximately 20% of channel flow at high tide.

However, Fig. 2c illustrates that the causeway dam effect is much more significant in tropical cyclones and storm surge conditions. These conditions occurred with the passage of Tropical Cyclone Paula across south western Fiji waters in March 2001, generating storm surge, large waves and swells (FIJI METEOROLOGICAL SERVICES 2001). The impact of the causeway dam effect in these extreme conditions is to hold back the strongest currents that should be generated around the north coast of Yanuca Island. The high surge waters are then forced to escape around the south coast of the island. This has the effect of increasing longshore drift along the south coast of Yanuca Island (PRASAD 1992), thus increasing the potential for erosion of the southern beaches.

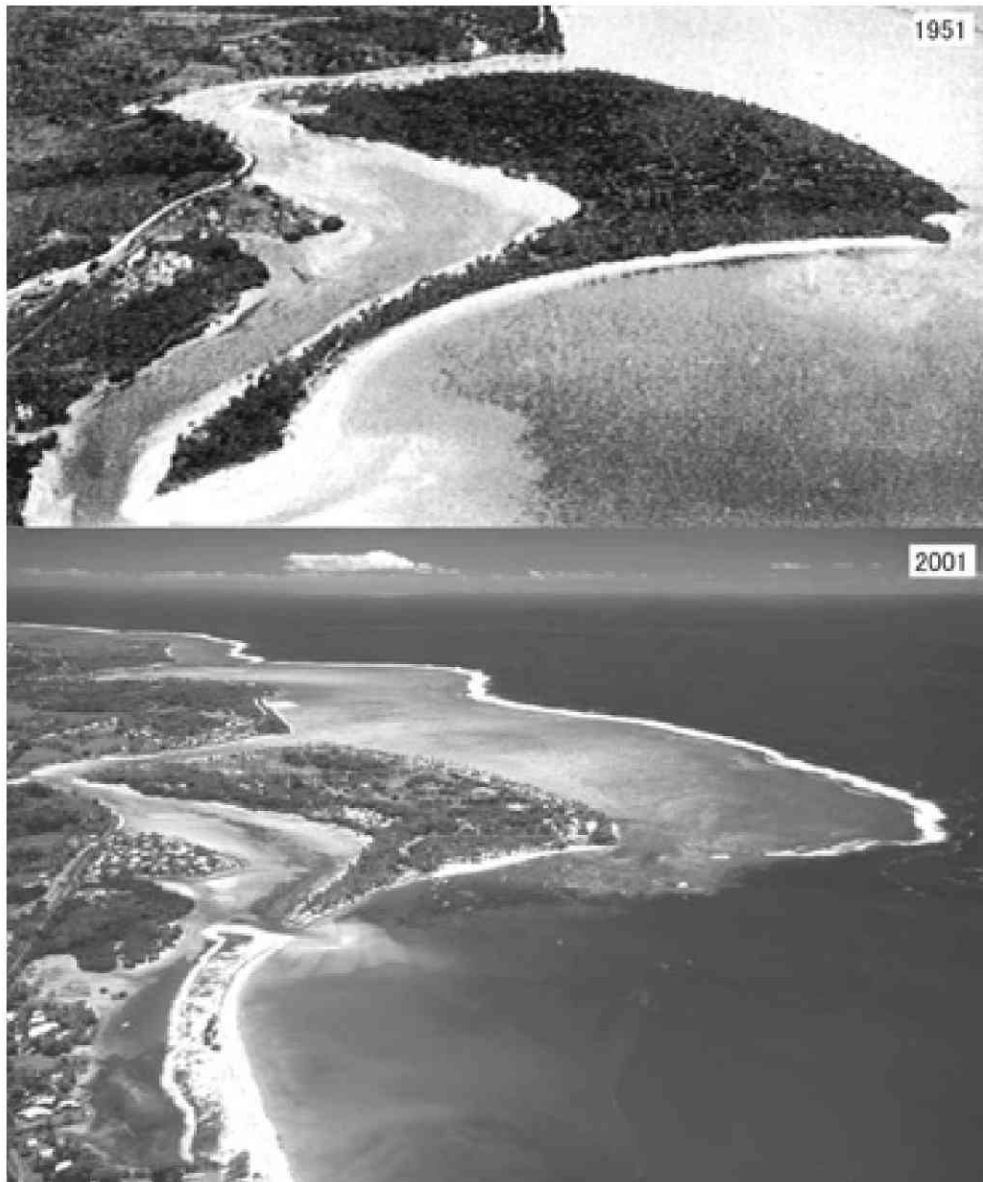
Fig. 3. Oblique aerial photographs of Yanuca Island in 1951 and 2001. Note the degradation of the sand bar in the bottom left of the image, the loss of coastal forest on the sand bar, and the consequent relocation of the drainage outlet of Yanuca Channel into Cuvu Bay.

Examination of historical reports and air photographs reveals that the coastline of northern end of Yanuca Island has not remained static but has changed substantially through time. Fig. 3 shows a pair of air photographs from 1951 and 2001, taken obliquely from a low altitude at approximately the same location over Cuvu Bay and viewing Yanuca Island in the same orientation. The 1951 photograph shows that a wide sand bar previously formed an approximately 400m long peninsular adjoining the north west point of the island. The bar is an elongated ridge of sand built by longshore drift and wave action. The bar sediments are composed of coralline materials, predominantly medium to coarse grain sands similar to the beaches elsewhere on Yanuca Island. In 1951 the sand bar was well vegetated with coconut trees and coastal shrubs. The presence of mature vegetation indicates that accretion was taking place and stable conditions had existed for some time. The position of the sand bar directed currents flowing through Yanuca Channel to exit into the central area of Cuvu Bay opposite Newtown settlement.
