PHYSICOCHEMICAL FEATURES OF THE “ SHIRASU ”
AND STABILITY OF THE FILLED SHIRASU AND THE
WEATHERED SHIRASU

Noboru ŌBA*, Masahiko YAMAMOTO*, Katsutoshi TOMITA* and Kōzō INOUE*

Abstract

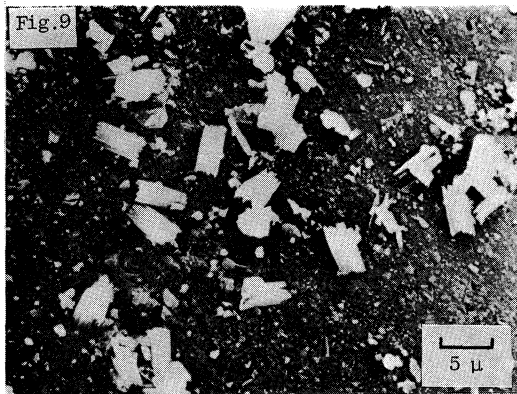
Fig. 9. Scanning electron microphotograph of typical fibrous volcanic glasses. Taken by Shimazu Seisakusho Ltd.

Volcanic glasses of several 10 to one μ in size, as shown in an electron microphotograph (Fig. 9) and a microphotograph (Fig. 8), occur in such a form as ascicular,

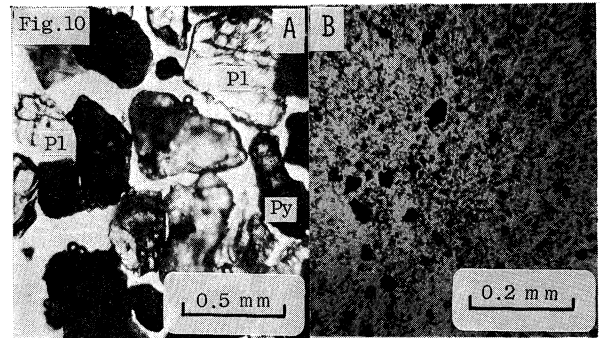
Fig. 10. Microphotographs of grains of river sand (A) consisting mostly of stable rock-forming minerals and constituent substance of loam (B) composing of clay minerals.

These facts clearly show that the Shirasu is essentially different from either common soil or common sand (Fig. 10). These natures are significant to understand why unexpected disasters of various patterns repeatedly happened in the Shirasu regions in the past.

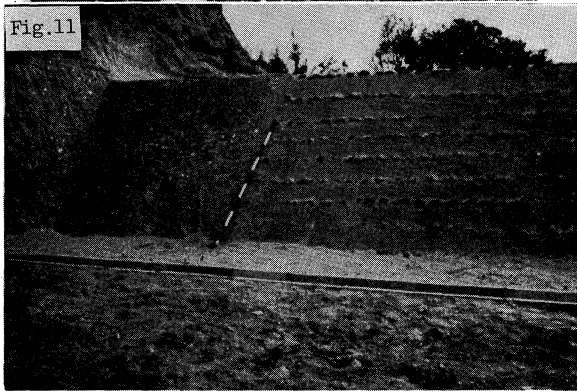
Fig. 11. Models with the face of slope with a gradient of 45° set up for out-door test for comparison of the stability of the primary Shirasu, on the left handed side, and physically compacted filled Shirasu with sodding, on the right handed side, against artificially prepared shower about 100 mm/h.

Fig. 11 shows two models which were set up for out-door test which was carried out in 1973 for making comparison of the stability of the primary Shirasu, on the left handed side, and physically compacted filled Shirasu, on the right handed side, against artificially prepared shower about 100 mm/h, corresponding to that of several times of the heavy rainfall. Fig. 12 shows the start of the out-door test. As is clear from Fig. 13, it was proved that the primary Shirasu is high in its stability for shower, and, in contrast, the compacted filled Shirasu is very easily eroded away in a short time.

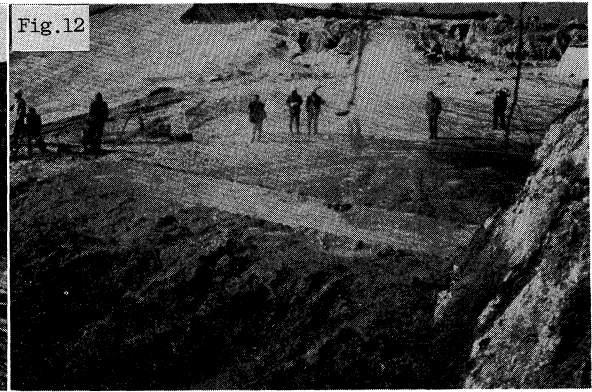
Fig. 12. Start of the our-door test.

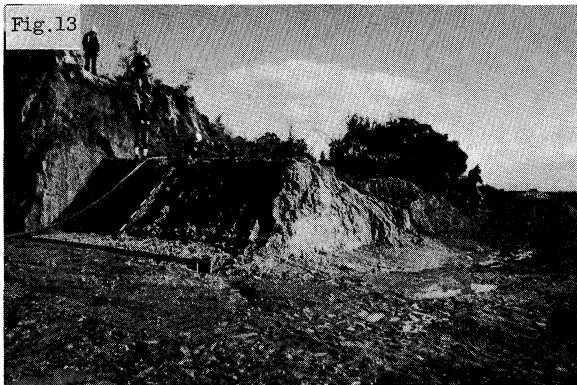
Fig. 13. After about 30 minutes, there was scarcely change on the face of the primary Shirasu, and, in contrast, the compacted filled Shirasu became loose and rushed out in a form of fluid.
