Features of Slope-Movements due to Heavy Rainfalls in the SHIRASU Region of Southern Kyushu

Motohisa HARUYAMA

ABSTRACT

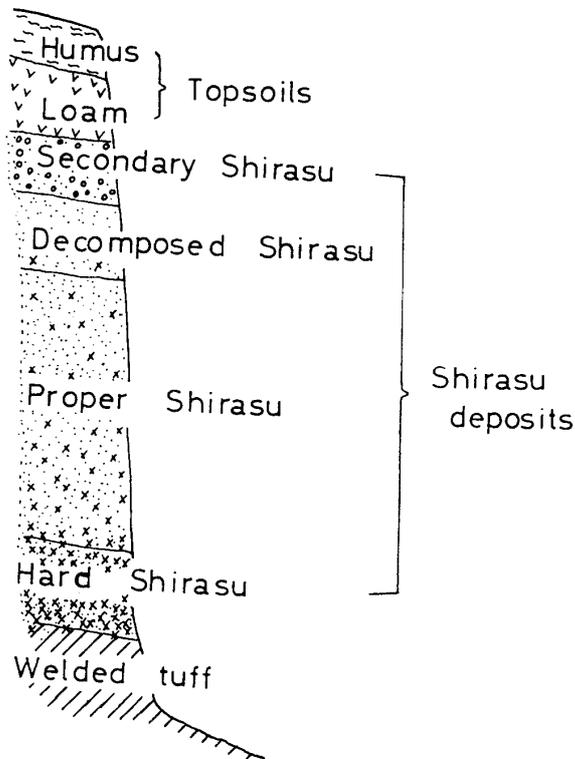
Fig. 1. Schematic section of hill-slope of Shirasu.

The beds of secondary and decomposed Shirasu are very easy to collapse, hard Shirasu suffers little from collapsing, and proper Shirasu has intermediate characteristics between the above two. Topsoil has a tendency to slide down over the Shirasu deposits.

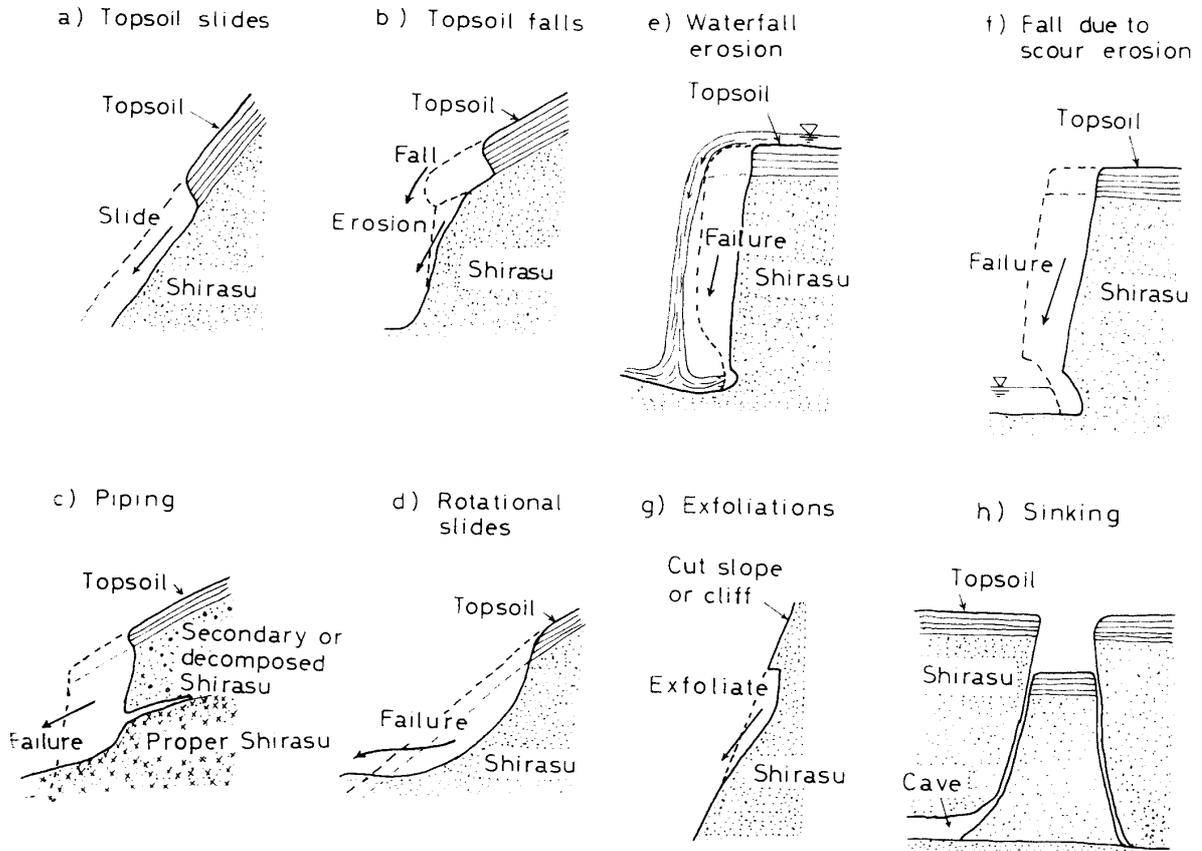
The basic types of slope-movements observable on the hill-slopes in Shirasu region during the period of heavy rainfall are illustrated diagrammatically in Fig. 2.

Fig. 2. Some basic types of mass-movements in Shirasu slopes
