# Damage caused by typhoon Nabi to slopes bordering forest roads in the Takakuma Experimental Forest, Kagoshima University, in September 2005

In order to clarify the nature and scale of the damage caused by typhoon Nabi in September 2005 to the slopes bordering the forest road through the Takakuma Experimental Forest at Kagoshima University, thirty five slopes bordering the road, damaged by typhoon Nabi, were investigated. Characteristic results were as follows:

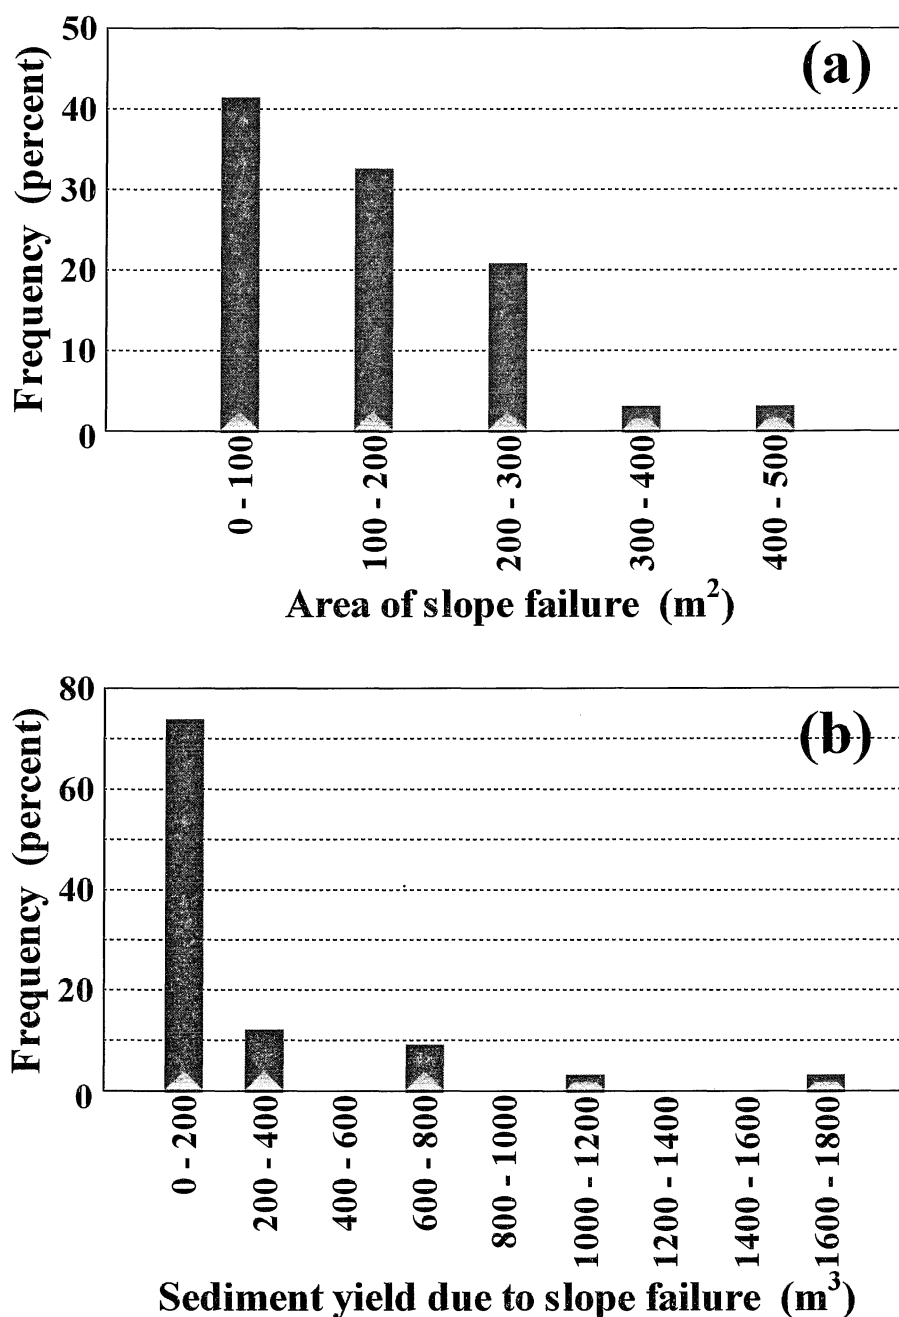
Fig. 8 Histograms showing (a) area of slope failure and (b) sediment yield due to a slope failure, within the study area.

Fig. 8 shows histograms of (a) area of slope failure and (b) sediment yield due to slope failure, within the study area. The area of slope failure ranged from 16 m<sup>2</sup> to 400 m<sup>2</sup> (average 133 m<sup>2</sup>). The sediment yield due to slope failure ranged from 10 m<sup>3</sup> to 1,600 m<sup>3</sup> (average 223 m<sup>3</sup>). Seventy percent of the areas of slope failure and the total sediment yield due to slope failure within the study area were below 200 m<sup>2</sup> and 300 m<sup>3</sup>, respectively. The principal types of large-scale slope failure, identified
