Dynamical Analysis of Rotary Tiller (II)

—Measurement of Stress on Chain Tightener—

Koichi IWASAKI, Yoshiteru MIYABE and Sumitaka KASHIWAGI

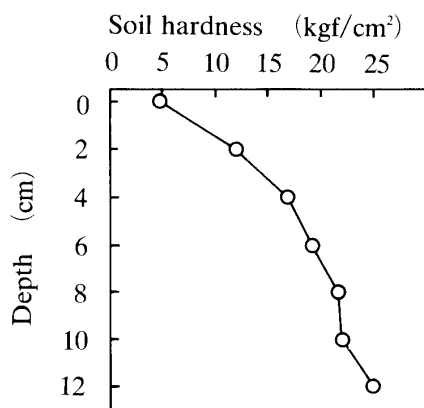
Fig. 2. Soil hardness of the tested field.

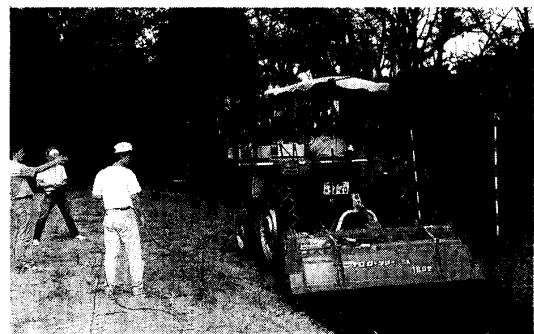
Fig. 3. Measurement with tractor and rotary tiller.

work, while the passing time of 3m was measured to calculate the moving speed. Under such conditions, the tightener was repeatedly tightened and loosened by the influence of the tillage resistance acting upon a rotary shaft. The stress data were amplified and recorded on Memory Hi Corder (HIOKI) mounted on the tractor as shown in Fig.3.

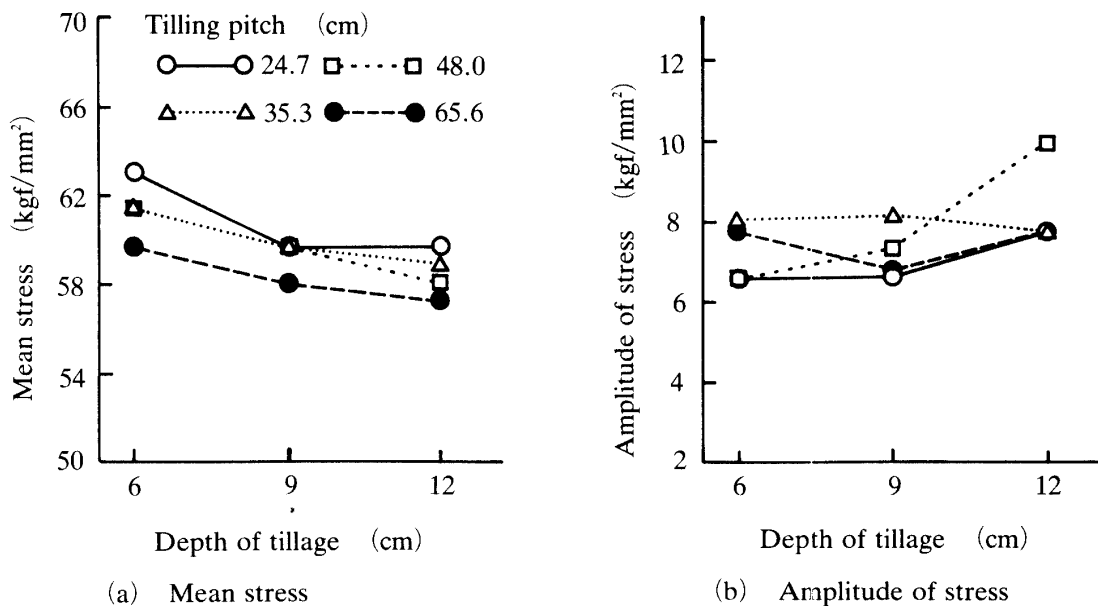
The measured mean stress and the amplitude of the stress at various depths of tillage are shown in Fig.4 (a), (b). As the depth of tillage increased from 6 to 12cm, the mean stress decreased gradually in every tilling pitch. Concretely, the mean stress decreased from around 61.3 to 58.4kgf/mm², which means the mean stress became lowered around 5% with the increase of the depth of tillage. On the other hand, the amplitude of the mean stress increased with the increase of the depth of tillage on the average. Concretely, the amplitude of the stress increased from around 7.2 to 8.3kgf/mm², which means the amplitude of the stress got raised around 15% with the increase of the depth of tillage.

Fig. 4. Influence of depth of tillage.

These trends described in 1. and 2. are considered to be caused by the reason mentioned below. Both increase of the depth of tillage and that of the tilling pitch caused the increase of the tillage resistance, and the chain on the opposite side of the tightener seemed to become tensed. Consequently, the chain on the tightener side was loosened; and this resulted in the decreasing of the mean stress of the tightener. While with the increase of the tillage resistance, the rotary shaft came to be suffered from the impact force, and so the amplitude of the stress increased.

(1) As the depth of tillage increased from 6 to 12cm, the mean stress decreased gradually from 61.3 to 58.4kgf/mm², while the amplitude of the stress increased from 7.2 to 8.3kgf/mm².

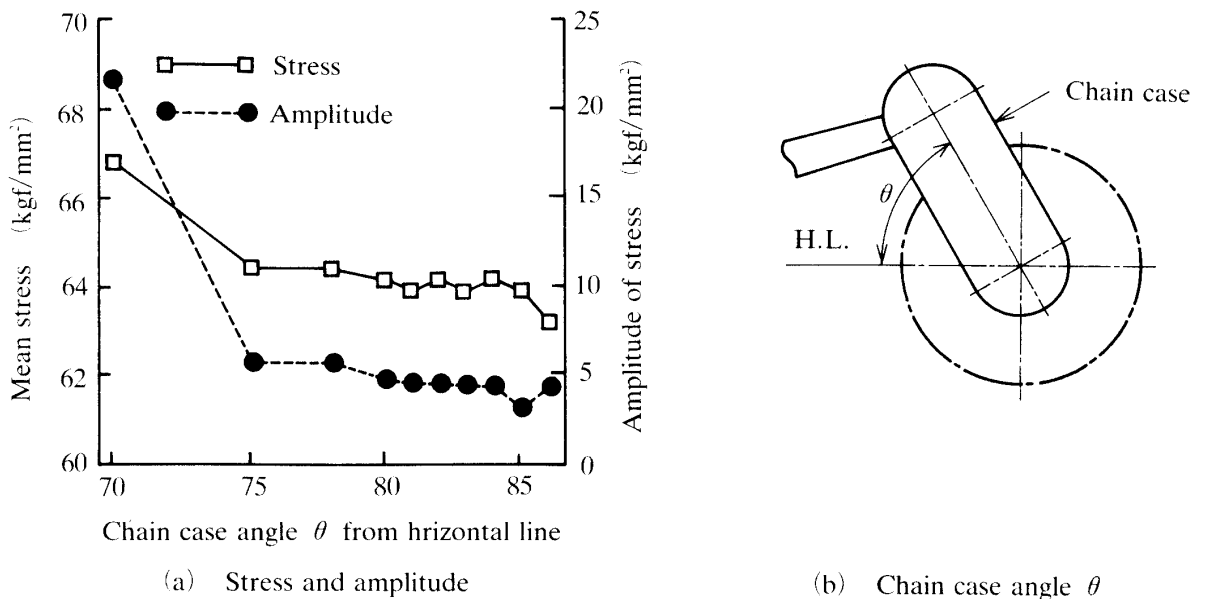
Fig. 6. Influence of the inclination of the chain case.

The measured mean stress and the amplitude of the stress are shown in Fig.6(a). The inclined angle means the angle between the center line of the chain case and the horizontal line (Fig.6(b)). When the inclined angle was small, the mean stress and the amplitude of the stress showed remarkably large value; and as the inclined angle increased, the mean stress and the amplitude of the stress abruptly decreased to nearly constant value. Concretely, as the inclined angle increased from 70 to 86deg, the mean stress came to be decreased from 66.8 to 64.1kgf/mm², which means that the mean stress became lowered around 4%. As for the amplitude of the stress, it decreased from 21.6 to 4.7kgf/mm², which means that

the amplitude of the stress came to be lowered around 78%.

The reason of these phenomena is considered to be as follows. When the chain case is inclined, the weight of the chain affected on the tightener and the mean stress of the tightener increased. As the influences of the clutching of the chain and the sprocket and of the chain link plate on the tightener, increased with the increase of the inclination of the chain case, the amplitude of the stress showed a larger value. These results indicate the fact that for the chain tightener a serious condition is brought about occurs when the chain case inclined so much, as the rotary tiller came to be lifted up at the each end of the field.

(3) The mean stress and the amplitude of the stress showed remarkably large value when the inclined angle of the chain case from the horizontal line was small, and as the angle increased, they abruptly decreased to nearly constant value.

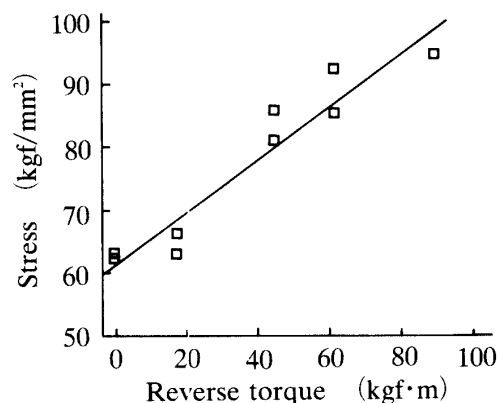
Fig. 8. Stress at reverse torque.

Measured stress at various torque are shown in Fig.8. As shown in this figure, as the torque increased the stress increased linearly. With the results of linear regression, the stress increased from 61.6 to 99.2kgf/mm², as the reverse torque increased from 0 to 90kgf · m.

This result suggests that the tightener suffers very serious conditons if the rotary tiller is equipped with reverse rotation mechanism.

(4) As ascertained by the reverse torque test, the stress of the tightener increased from 61.6 to 99.2kgf/mm² as the reverse torque increased from 0 to 90kgf · m. This result indicates that the tightener suffers serious defect due to the reverse rotation of a rotary tiller.

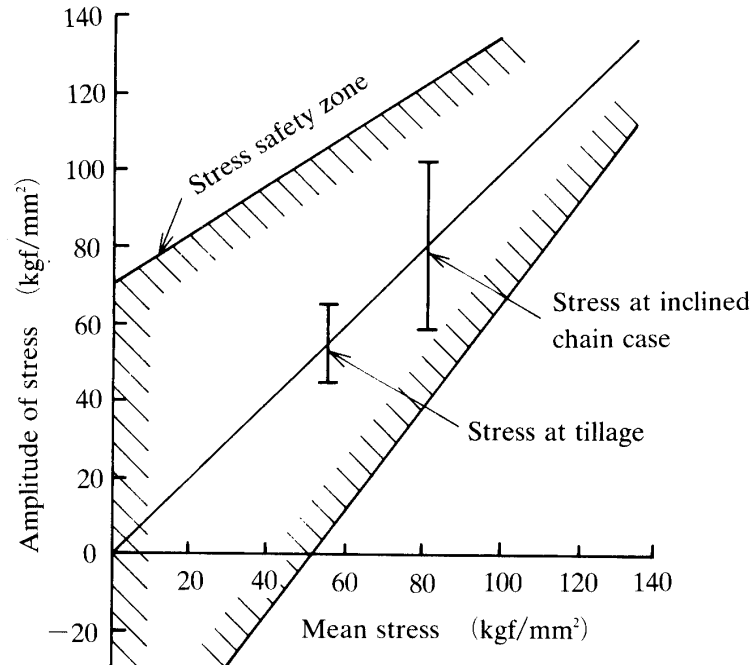
The material of the tightener is SK5P whose completely reversed fatigue limit σ_s is 204 to 296kgf/mm², and the tensile strength σ_w can be calculated, multiplying σ_s by 0.35. The obtained fatigue limit diagram of the tested material is shown in Fig.9. The hatched area shows the safety zone for the material. The measured mean stress and the amplitude of the stress are indicated in that diagram at the tillage test and the chain case inclination test. After comparing the size of the measured stress and the safety zone of the material, the tightener is considered to have an adequate quality in its strength.

Fig. 9. Measured stress and fatigue limit diagram of SK5P.

(5) Judging from the measured stress of the tightener and the safety zone of the material SK5P, the tightener was considered to be in possession of an adequate quality seen from the view point of the fatigue strength.
